## General Information

| Make | Toyota | Model | Vios |
| Registration No. | FAQ3110 | Chassis No. | PA1B18F37P4228008 |

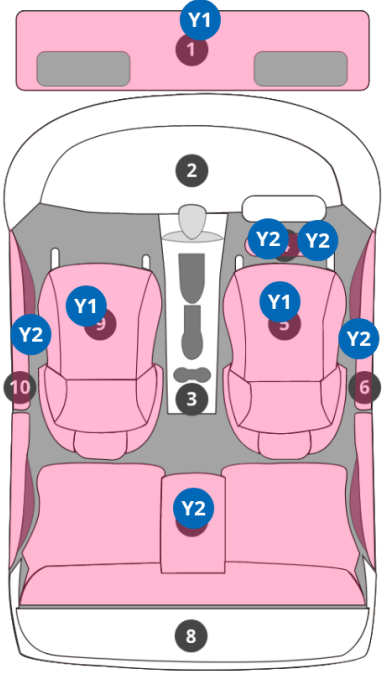
| Interior Evaluation : <b>B</b> | Exterior Evaluation : <b>E</b> |
|---|---|
| <p><b>Remarks</b><br/>(R) Front Trim - Grime - Small / (R) Front Seat - Grime - Minimal / (L) Front Seat - Grime - Minimal / Rear Seat - Grime - Small / (R) Front Floor Mat - Grime - Small / (L) Front Floor Mat - Grime - Small / Ceiling - Grime - Minimal / (L) Front Trim - Grime - Small</p> | <p><b>Remarks</b><br/>(L) Front Fender, Molding - Scratch &amp; Dent - Medium / (L) Front Door, Molding - Scratch - Small / (L) Step, In-panel, Side Spoiler - Scratch - Small / (L) Rear Door, Molding - Scratch - Small / (L) Rear Fender, Molding - Scratch - Small / Rear Bumper, Lamps, Panels - Scratch - Medium / Trunk Hood, Rear Gate - Scratch - Small / (R) Rear Fender, Molding - Scratch - Medium / (R) Rear Door, Molding - Scratch - Medium / (R) Step, In-panel, Side Spoiler - Scratch - Small / (R) Front Door, Molding - Scratch - Small / (R) Front Fender, Molding - Crack, Gap - Medium / Front Bumper, Grille, Lamps - Scratch - Large / Bonnet, Headlight - Scratch - Minimal / Roof - Scratch - Small</p> |

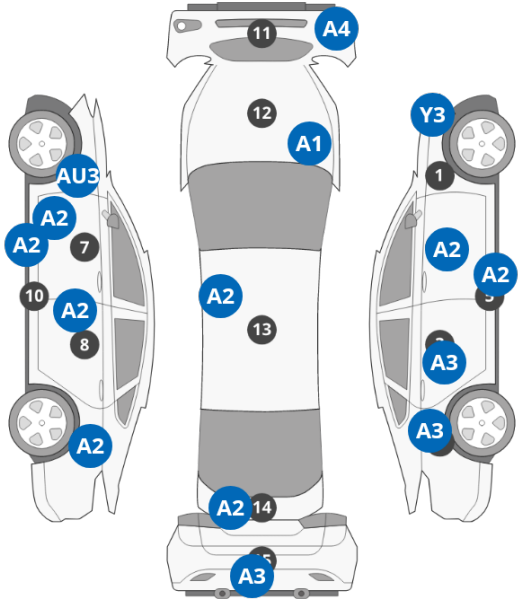
with LTO plate/no warranty booklet/with incomplete tools with jack/with spare tire/air recirculating button issue/headlight cover cracked/hairline scratches on the body
