## General Information

| Make | Toyota | Model | Avanza |
| Registration No. | FAS9142 | Chassis No. | MHFAA1BY4S0039059 |

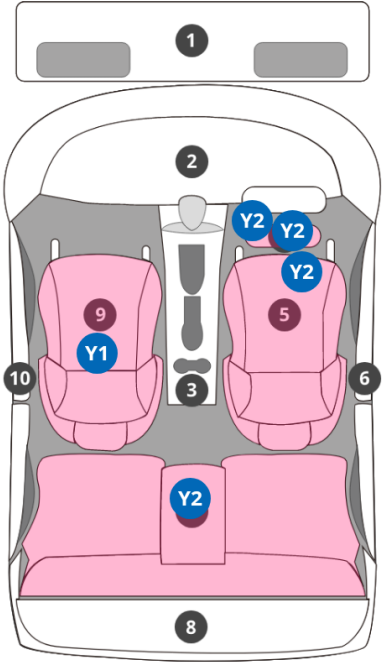
| Interior Evaluation : <b>B</b> | Exterior Evaluation : <b>D</b> |
|---|---|
| <p><b>Remarks</b><br/>(R) Front Floor Mat - Grime - Small / (L) Front Floor Mat - Grime - Small / (R) Front Seat - Grime - Small / (L) Front Seat - Grime - Minimal / Rear Seat - Grime - Small</p> | <p><b>Remarks</b><br/>(R) Front Fender, Molding - Scratch - Minimal / (R) Front Door, Molding - Scratch - Medium / (R) Rear Door, Molding - Scratch - Minimal / (R) Step, In-panel, Side Spoiler - Scratch - Small / (R) Rear Fender, Molding - Scratch - Minimal / Rear Bumper, Lamps, Panels - Dent - Medium / Trunk Hood, Rear Gate - Scratch &amp; Dent - Medium / (L) Rear Fender, Molding - Scratch - Small / (L) Rear Door, Molding - Scratch &amp; Dent - Small / (L) Front Door, Molding - Scratch &amp; Dent - Small / (L) Mirror - Scratch - Minimal / (L) Front Fender, Molding - Dent - Small / Bonnet, Headlight - Scratch - Small / Front Bumper, Grille, Lamps - Scratch &amp; Dent - Medium / Roof - Scratch - Minimal</p> |

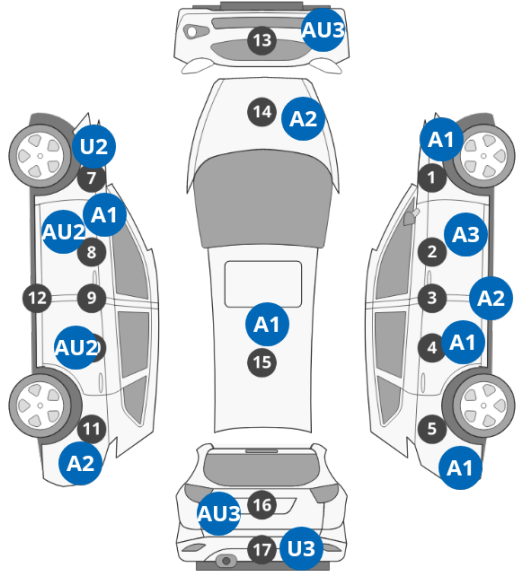
| Inspector Notes |
|---|
| with LTO plate, no warranty booklet, with incomplete tools, with jack, with spare tier, rear parking sensor issue, hairline scratches on the body |
