## General Information

| Make | Toyota | Model | Vios |
| YOM | 2023 | Odo Meter Reading | 1 |
| Registration No. | CCA2151 | Chassis No. | PA1B18F3XP4224020 |

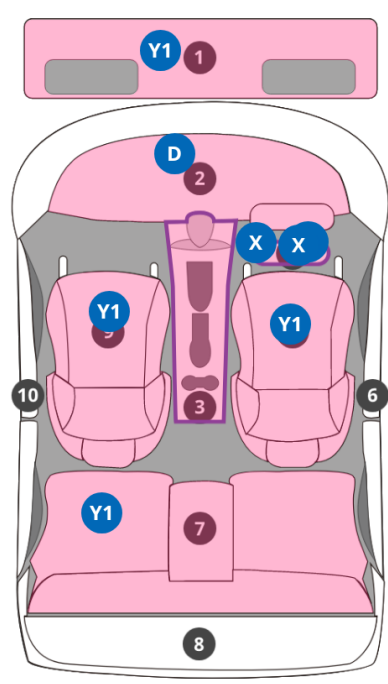
| <div> <div>Remarks</div> <div>Display, Audio System - Missing - Yes / (L) Front Seat - Grime - Minimal / (R) Front Seat - Grime - Minimal / (L) Front Floor Mat - Missing - Yes / (R) Front Floor Mat - Missing - Yes / Mat Other - Missing - Yes / Rear Seat - Grime - Minimal / Dashboard - Traces of Adhesive Tape - Yes / Ceiling - Grime - Minimal / Overall Interior - Worn as per age - Yes</div> </div> | <div> <div>Remarks</div> <div>Front Bumper, Grille, Lamps - Scratch - Medium / (R) Rear Door, Molding - Scratch &amp; Dent - Small / (R) Front Door, Molding - Scratch - Minimal / (R) Front Fender, Molding - Scratch - Minimal / (R) Rear Fender, Molding - Scratch - Minimal / Trunk Hood, Rear Gate - Scratch - Minimal / Rear Bumper, Lamps, Panels - Scratch - Minimal / Roof - Scratch - Minimal / (L) Rear Fender, Molding - Scratch - Minimal / (L) Rear Door, Molding - Scratch - Minimal / (L) Front Door, Molding - Scratch - Minimal / (L) Front Fender, Molding - Scratch - Minimal / Bonnet, Headlight - Scratch - Minimal / (L) Step, In-panel, Side Spoiler - Scratch - Minimal / (R) Step, In-panel, Side Spoiler - Scratch - Small</div> </div> |

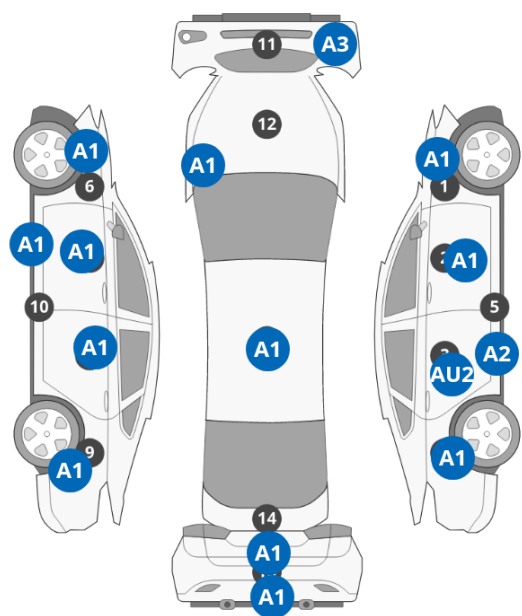
with front lto plate only/non moving unit/functional cannot identified/Scratches and dent on the body
