## General Information

| Make | Toyota | Model | Vios |
| Registration No. | NHC2809 | Chassis No. | PA1B18F30N4190926 |

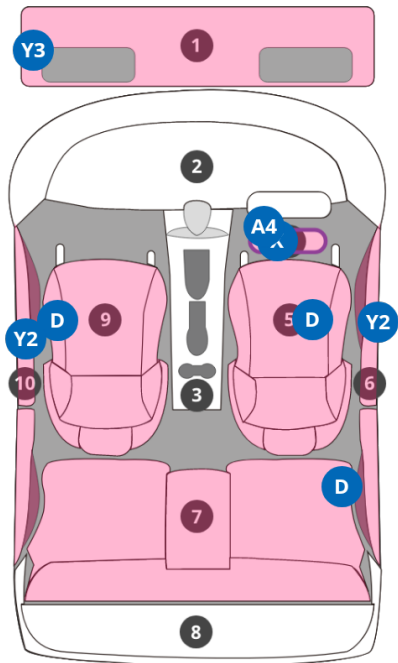
| Interior Evaluation : <span style="color: red;">C</span> | Exterior Evaluation : <span style="color: red;">C</span> |
|---|---|
| <p><b>a</b> : Cut, Fray <b>d</b> : Loose, Deformed <b>k</b> : Animal Hair <b>s</b> : Smell <b>t</b> : Cigarette Burns <b>x</b> : Defective <b>y</b> : Stain</p> | <p><b>A</b> : Scratch <b>AU</b> : Scratch &amp; Dent <b>B</b> : Modified <b>C</b> : Corrosion <b>G</b> : Stone chip <b>P</b> : Faded <b>S</b> : Rust <b>SC</b> : Rust &amp; Corrosion <b>U</b> : Dent <b>X</b> : Defective <b>Y</b> : Crack, Gap</p> |
| <p><b>Remarks</b></p> <p>Mat Other - Missing - Yes / (L) Front Floor Mat - Cut, Crack - Large / (L) Front Seat - Worn - Yes / (R) Front Seat - Worn - Yes / Rear Seat - Worn - Yes / Ceiling - Grime - Medium / (L) Front Trim - Grime - Small / (R) Front Trim - Grime - Small</p> | <p><b>Remarks</b></p> <p>(R) Front Fender, Molding - Scratch - Small / (R) Mirror - Scratch - Small / (R) Front Door, Molding - Scratch - Small / (R) Rear Door, Molding - Scratch - Minimal / (R) Rear Fender, Molding - Scratch - Medium / Rear Bumper, Lamps, Panels - Scratch - Small / Trunk Hood, Rear Gate - Scratch - Minimal / (L) Rear Fender, Molding - Scratch - Small / (L) Front Door, Molding - Scratch - Medium / (L) Rear Door, Molding - Scratch - Small / (L) Mirror - Scratch - Minimal / (L) Front Fender, Molding - Scratch - Small / Front Bumper, Grille, Lamps - Scratch - Small / Bonnet, Headlight - Scratch - Small / Roof - Scratch - Minimal</p> |

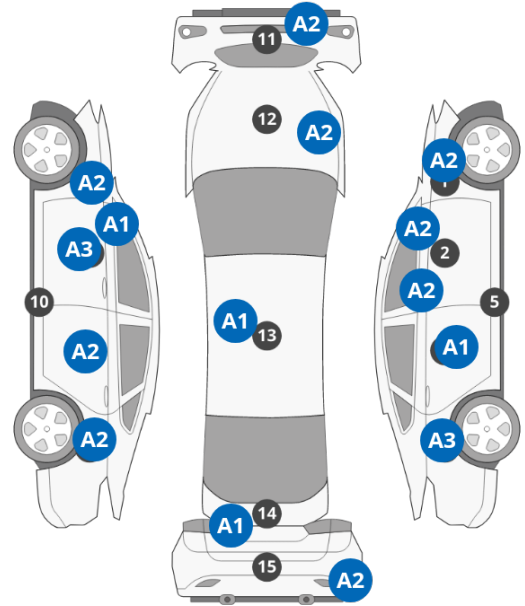
non moving unit, functional and mileage can't verify due to non moving unit, no warranty booklet,with jack, incomplete tools, with spare tire, with LTO plate, scratches on tail light, other scratches on exterior can't verify due to build up dirt
