## General Information

| Make | Toyota | Model | Wigo |
| YOM | 2024 | Mileage | 16,797 |

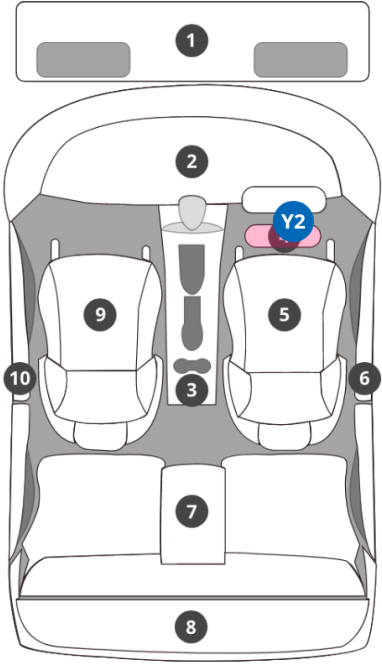
| Interior Evaluation : <span style="color: red;">A</span> | Exterior Evaluation : <span style="color: red;">B</span> |
| <b>Remarks</b><br>Mat Other - Grime - Small | <b>Remarks</b><br>Bonnet, Headlight - Dent - Minimal / Front Bumper, Grille, Lamps - Scratch - Small / Trunk Hood, Rear Gate - Dent - Small / (L) Front Door, Molding - Scratch - Small / (L) Step, In-panel, Side Spoiler - Scratch - Small |
