## General Information

| Make | Toyota | Model | Avanza |
| Registration No. | NHS3842 | Chassis No. | MHFAB1BYXR3103322 |

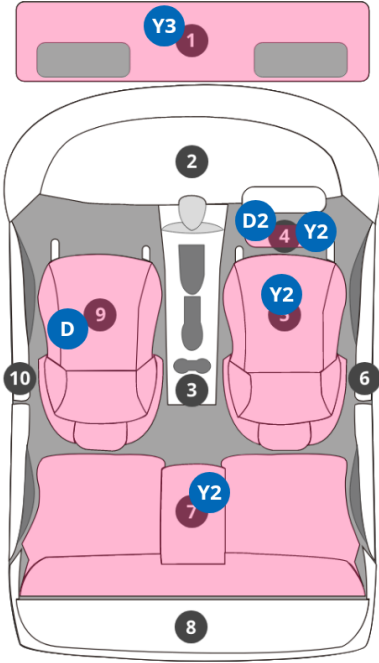
| Interior Evaluation : <b>B</b> | Exterior Evaluation : <b>E</b> |
|---|---|
| <p><b>Remarks</b><br/>(R) Front Seat - Grime - Small / Rear Seat - Grime - Small / (R) Front Floor Mat - Grime - Small / (L) Front Floor Mat - Worked - Small / (L) Front Seat - Worn - Yes / Ceiling - Grime - Medium</p> | <p><b>Remarks</b><br/>Bonnet - Repair Traces - Yes / Bonnet, Headlight - Repair mark - Yes / (R) Front Fender, Molding - Scratch - Small / (R) Front Door, Molding - Scratch - Large / (R) Step, In-panel, Side Spoiler - Scratch - Medium / (R) Rear Fender, Molding - Scratch - Small / Rear Bumper, Lamps, Panels - Scratch - Medium / Trunk Hood, Rear Gate - Scratch - Minimal / (L) Rear Door, Molding - Scratch &amp; Dent - Medium / (L) Step, In-panel, Side Spoiler - Scratch - Small / (L) Mirror - Scratch - Minimal / (L) Front Door, Molding - Scratch &amp; Dent - Small / (L) Front Fender, Molding - Scratch - Small / Front Bumper, Grille, Lamps - Scratch - Large / Bonnet, Headlight - Scratch - Minimal / Roof - Scratch &amp; Dent - Minimal / (R) Rear Door, Molding - Scratch &amp; Dent - Small / (L) Rear Fender, Molding - Scratch &amp; Dent - Small</p> |
