## General Information

| Make | Toyota | Model | Vios |

## Body / Panel Condition

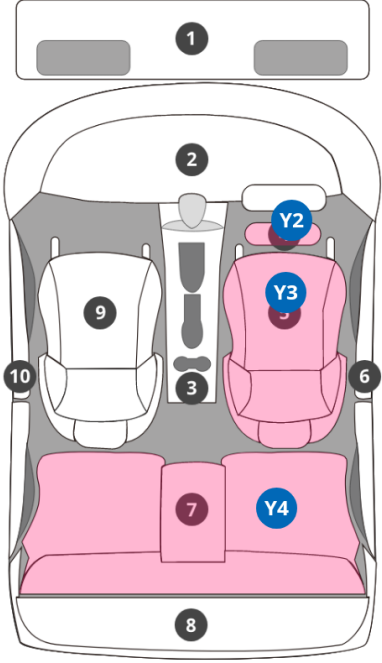
| Interior Evaluation : <b>C</b> | Exterior Evaluation : <b>E</b> |
| <p><b>Remarks</b><br/>(L) Front Floor Mat - Grime - Small / Rear Seat - Grime - Large / (R) Front Seat - Grime - Medium</p> | <p><b>Remarks</b><br/>(L) Front Door, Molding - Scratch &amp; Dent - Large / (L) Step, In-panel, Side Spoiler - Scratch &amp; Dent - Large / Rear Bumper, Lamps, Panels - Scratch - Large / Trunk Hood, Rear Gate - Scratch &amp; Dent - Small / (R) Rear Fender, Molding - Scratch &amp; Dent - Large / (R) Rear Door, Molding - Scratch &amp; Dent - Large / (R) Front Door, Molding - Scratch &amp; Dent - Medium / (R) Step, In-panel, Side Spoiler - Scratch &amp; Dent - Large / (R) Front Fender, Molding - Dent - Large / Front Bumper, Grille, Lamps - Scratch &amp; Dent - Large / (L) Front Fender, Molding - Dent - Minimal / (L) Rear Door, Molding - Dent - Minimal</p> |

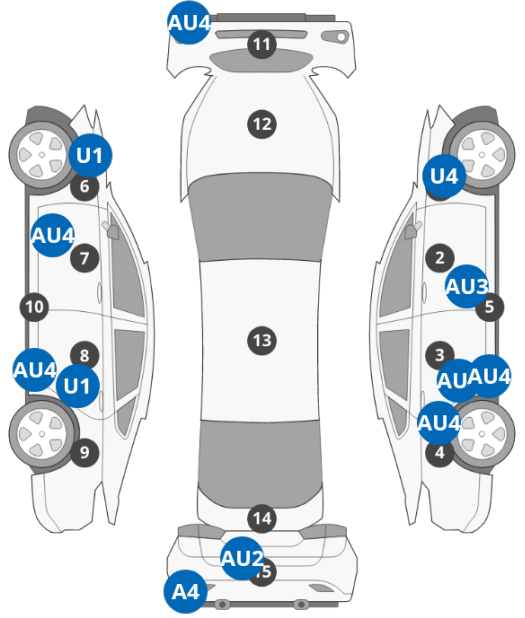
| Inspector Notes |
|---|
| with LTO plate/with spare tire/with jack /No tools and warranty booklet/right side mirror damage |
