## General Information

| Make | Toyota | Model | Wigo |
| Registration No. | DAV3642 | Chassis No. | MHKA4DF5FMJ055990 |

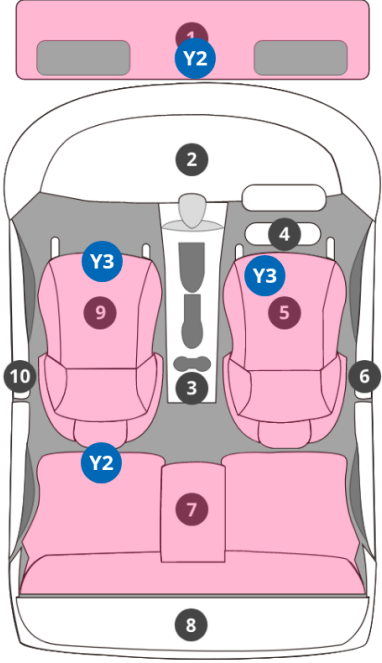
| <b>Remarks</b><br>Ceiling - Grime - Small / Rear Seat - Grime - Small / (L) Front Seat - Grime - Medium / (R) Front Seat - Grime - Medium | <b>Remarks</b><br>(L) Rear Fender - Repair Traces - Yes / (R) Front Fender, Molding - Scratch & Dent - Small / (R) Front Door, Molding - Scratch & Dent - Medium / (R) Rear Door, Molding - Scratch - Medium / (R) Step, In-panel, Side Spoiler - Dent - Small / (R) Rear Fender, Molding - Dent - Minimal / (L) Mirror - Scratch - Minimal / Bonnet, Headlight - Scratch & Dent - Minimal / (L) Rear Door, Molding - Scratch - Small / (L) Front Door, Molding - Scratch - Small / (L) Rear Fender, Molding - Scratch - Small / Front Bumper, Grille, Lamps - Scratch & Dent - Large / Rear Bumper, Lamps, Panels - Scratch - Medium |
