## General Information

| Make | Toyota | Model | Vios |

## Body / Panel Condition

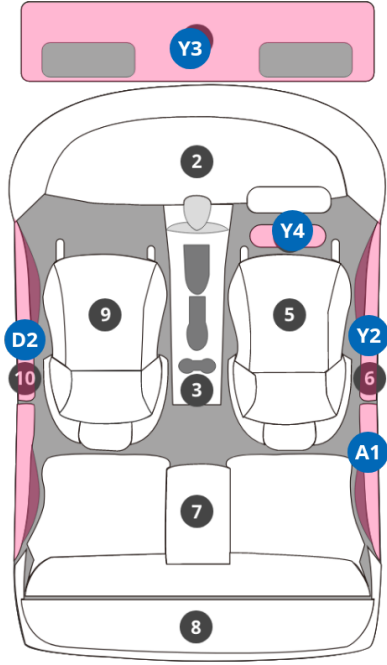
| Interior Evaluation : <span style="color: red;">C</span> | Exterior Evaluation : <span style="color: red;">D</span> |
| <p><b>Remarks</b></p> <p>Mat Other - Grime - Large / (R) Rear Trim - Cut, Crack - Minimal / (R) Front Trim - Grime - Small / (L) Front Trim - Worked - Small / Ceiling - Grime - Medium</p> | <p><b>Remarks</b></p> <p>(L) Rear Fender - Repair Traces - Yes / Trunk Hood, Rear Gate - Repair Traces - Yes / (R) Step, In-panel, Side Spoiler - Scratch &amp; Dent - Large / (R) Rear Fender, Molding - Scratch - Minimal / Trunk Hood, Rear Gate - Scratch - Small / Rear Bumper, Lamps, Panels - Repair mark - Yes / (L) Rear Fender, Molding - Dent - Small / (L) Mirror - Scratch - Small / (L) Front Door, Molding - Scratch - Minimal / Front Bumper, Grille, Lamps - Scratch - Medium / Bonnet, Headlight - Scratch - Minimal / Rear Bumper, Lamps, Panels - Crack, Gap - Medium / (R) Rear Door, Molding - Scratch &amp; Dent - Medium / (R) Front Door, Molding - Scratch &amp; Dent - Medium / (R) Mirror - Scratch - Minimal / (L) Rear Door, Molding - Scratch &amp; Dent - Minimal</p> |
