## General Information

| Make | MG | Model | MG 5 |
| Registration No. | GB07602 | Chassis No. | LSJA36E35SZ186178 |

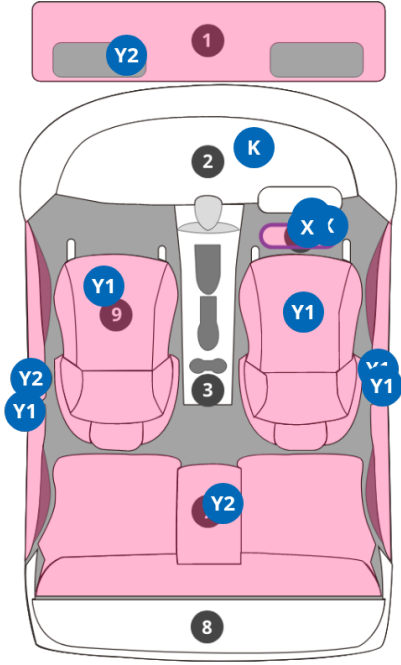
| Interior Evaluation : <b>B</b> | Exterior Evaluation : <b>C</b> |
|---|---|
| <p><b>a</b> : Cut, Fray <b>d</b> : Loose, Deformed <b>k</b> : Animal Hair <b>s</b> : Smell <b>t</b> : Cigarette Burns <b>x</b> : Defective <b>y</b> : Stain</p> | <p><b>A</b> : Scratch <b>AU</b> : Scratch &amp; Dent <b>B</b> : Modified <b>C</b> : Corrosion <b>G</b> : Stone chip <b>P</b> : Faded <b>S</b> : Rust <b>SC</b> : Rust &amp; Corrosion <b>U</b> : Dent <b>X</b> : Defective <b>Y</b> : Crack, Gap</p> |
| <p><b>Remarks</b></p> <p>Ceiling - Grime - Small / (R) Front Floor Mat - Missing - Yes / (L) Front Floor Mat - Missing - Yes / Mat Other - Missing - Yes / (L) Front Seat - Grime - Minimal / (R) Front Seat - Grime - Minimal / (R) Front Trim - Grime - Minimal / Rear Seat - Grime - Small / (R) Rear Trim - Grime - Minimal / (L) Front Trim - Grime - Small / (L) Rear Trim - Grime - Minimal / Overall Interior - Animal Hair - Yes</p> | <p><b>Remarks</b></p> <p>Front Bumper, Grille, Lamps - Scratch - Small / Bonnet, Headlight - Scratch - Medium / (R) Front Fender, Molding - Scratch - Small / (R) Front Door, Molding - Scratch - Small / (R) Step, In-panel, Side Spoiler - Scratch - Minimal / (R) Rear Door, Molding - Scratch - Minimal / (R) Rear Fender, Molding - Scratch - Minimal / Trunk Hood, Rear Gate - Scratch - Medium / Rear Bumper, Lamps, Panels - Scratch - Small / (L) Rear Fender, Molding - Scratch - Medium / (L) Rear Door, Molding - Scratch - Small / (L) Step, In-panel, Side Spoiler - Scratch - Small / (L) Front Door, Molding - Scratch - Small / (L) Mirror - Scratch - Minimal</p> |
