## General Information

| Make | Toyota | Model | Vios |

## Body / Panel Condition

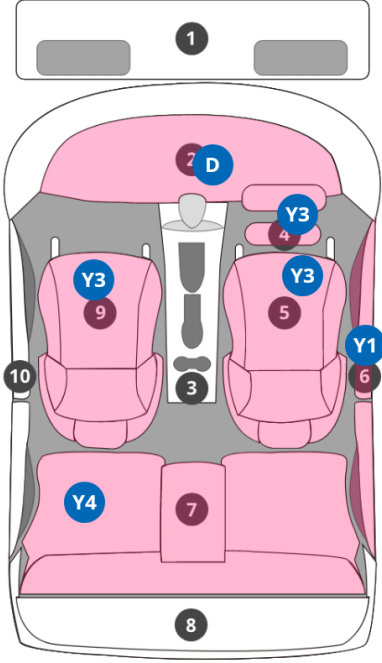
| Interior Evaluation : <span style="color: red;">C</span> | Exterior Evaluation : <span style="color: red;">C</span> |
| <p><b>Remarks</b><br/>Mat Other - Grime - Medium / (R) Front Seat - Grime - Medium / Rear Seat - Grime - Large / (L) Front Seat - Grime - Medium / Dashboard - Traces of Adhesive Tape - Yes / (R) Front Trim - Grime - Minimal</p> | <p><b>Remarks</b><br/>(R) Front Fender, Molding - Dent - Medium / (R) Step, In-panel, Side Spoiler - Scratch &amp; Dent - Medium / (R) Front Door, Molding - Scratch - Minimal / (R) Rear Fender, Molding - Dent - Small / Rear Bumper, Lamps, Panels - Scratch - Medium / Trunk Hood, Rear Gate - Scratch - Minimal / (L) Front Door, Molding - Scratch - Small / (L) Mirror - Scratch - Small / Front Bumper, Grille, Lamps - Scratch - Medium / (L) Rear Door, Molding - Scratch - Minimal / Bonnet, Headlight - Scratch - Minimal</p> |
