## General Information

| Make | Toyota | Model | Vios |

## Body / Panel Condition

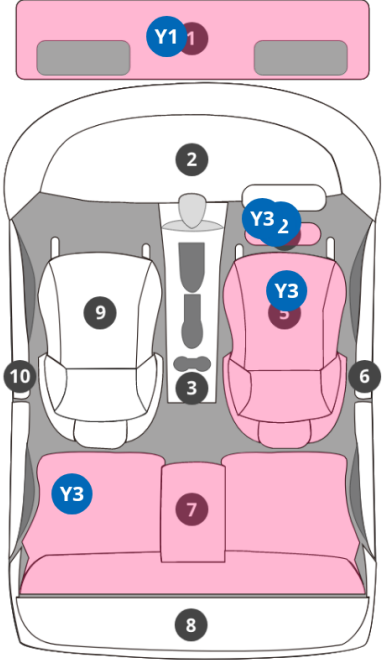
| <b>Remarks</b><br>Rear Seat - Grime - Medium / (R) Front Seat - Grime - Medium / (R) Front Floor Mat - Grime - Medium / (L) Front Floor Mat - Worked - Small / (L) Front Floor Mat - Grime - Medium / Ceiling - Grime - Minimal | <b>Remarks</b><br>(R) Front Fender - Repair Traces - Yes / (L) Front Fender - Repair Traces - Yes / (L) Rear Door - Repair Traces - Yes / Member (Bolted) - Dent - Yes / Front Bumper, Grille, Lamps - Scratch & Dent - Large / (R) Front Door, Molding - Scratch - Minimal / (R) Step, In-panel, Side Spoiler - Scratch & Dent - Large / (R) Rear Fender, Molding - Scratch & Dent - Medium / Rear Bumper, Lamps, Panels - Scratch & Dent - Small / Trunk Hood, Rear Gate - Scratch & Dent - Minimal / (L) Rear Fender, Molding - Scratch - Minimal / (L) Rear Door, Molding - Scratch & Dent - Medium / (L) Front Door, Molding - Scratch - Minimal / (L) Front Fender, Molding - Scratch & Dent - Minimal / (R) Rear Door, Molding - Scratch & Dent - Medium / (R) Front Fender, Molding - Scratch - Minimal |
