## General Information

| Make | Toyota | Model | Vios |
| YOM | 2021 | Mileage | 93,024 |

## Body / Panel Condition

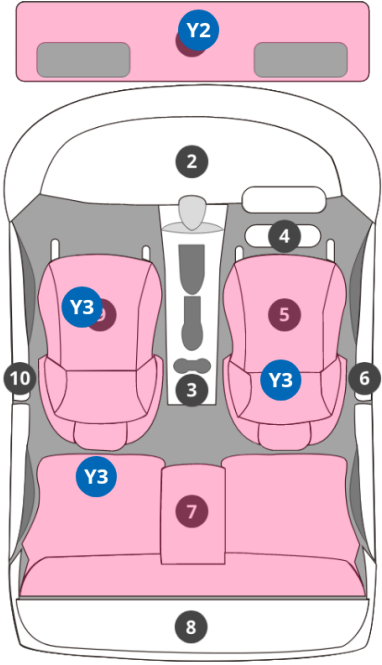
| Interior Evaluation : <b>B</b> | Exterior Evaluation : <b>E</b> |
| <p><b>Remarks</b><br/>(R) Front Seat - Grime - Medium / Rear Seat - Grime - Medium / (L) Front Seat - Grime - Medium / Ceiling - Grime - Small</p> | <p><b>Remarks</b><br/>(R) Rear Door - Repair Traces - Yes / Bonnet, Headlight - Dent - Medium / (L) Rear Fender, Molding - Scratch &amp; Dent - Large / (L) Front Door, Molding - Scratch &amp; Dent - Large / Front Bumper, Grille, Lamps - Scratch &amp; Dent - Large / Rear Bumper, Lamps, Panels - Scratch &amp; Dent - Large / Trunk Hood, Rear Gate - Scratch &amp; Dent - Small / (R) Rear Door, Molding - Scratch &amp; Dent - Large / Roof - Dent - Small / (R) Mirror - Scratch - Small / (R) Front Door, Molding - Dent - Small / (R) Rear Fender, Molding - Scratch &amp; Dent - Medium / (L) Mirror - Scratch - Small</p> |
