## General Information

| Make | Toyota | Model | Vios |

## Body / Panel Condition

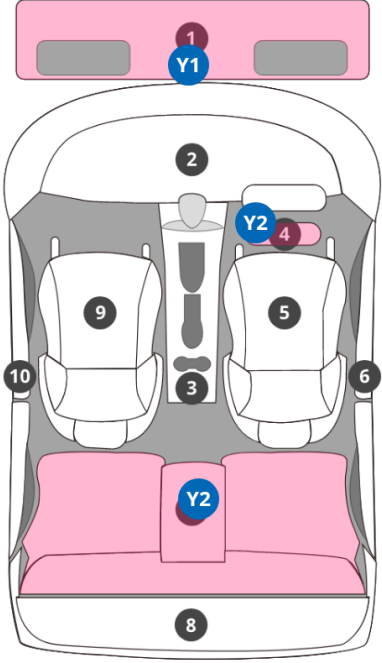
| <b>Interior Evaluation :</b> <span style="color: red; font-weight: bold;">A</span> | <b>Exterior Evaluation :</b> <span style="color: red; font-weight: bold;">A</span> |
| <b>Remarks</b><br>Ceiling - Grime - Minimal / Rear Seat - Grime - Small / (L) Front Floor Mat - Grime - Small | <b>Remarks</b><br>(R) Rear Door, Molding - Scratch - Minimal / (R) Front Door, Molding - Scratch - Small / (L) Mirror - Scratch - Minimal / (R) Front Fender, Molding - Scratch - Small / (R) Mirror - Scratch - Minimal |
