## General Information

| Make | Toyota | Model | Vios |
| YOM | 2023 | Mileage | 60,921 |

## Body / Panel Condition

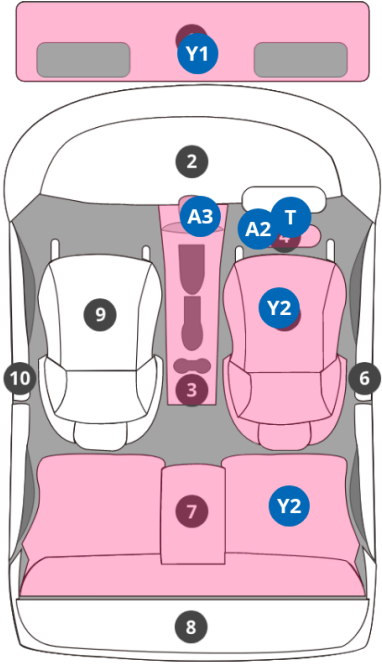
| Interior Evaluation : <b>B</b> | Exterior Evaluation : <b>C</b> |
|---|---|
| <p><b>Remarks</b><br/> Ceiling - Grime - Minimal / (R) Front Seat - Grime - Small / Rear Seat - Grime - Small / (L) Front Floor Mat - Cut, Crack - Small / Carpet - Cigarette Burns - Burnt / Console, Switchs, Vents - Worn, Scratch, Cut, Crack - Medium</p> | <p><b>Remarks</b><br/> (L) Rear Fender, Molding - Dent - Minimal / (L) Mirror - Scratch - Small / Front Bumper, Grille, Lamps - Scratch - Large / (R) Rear Door, Molding - Scratch - Medium / (R) Rear Fender, Molding - Scratch - Small / Rear Bumper, Lamps, Panels - Scratch - Small</p> |
