## General Information

Date & Time: 22, Feb, 2025 14:46

| Make | Toyota | Model | Vios |

## Body / Panel Condition

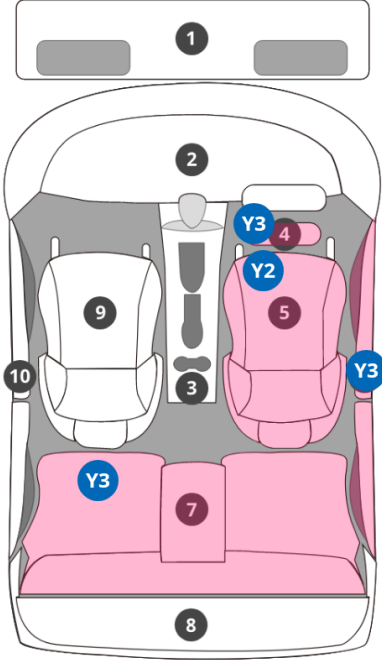
| Interior Evaluation : <b>B</b> | Exterior Evaluation : <b>A</b> |
| <p><b>Remarks</b><br/>(R) Rear Trim - Grime - Medium / (R) Front Seat - Grime - Small / Rear Seat - Grime - Medium / (L) Front Floor Mat - Grime - Medium</p> | <p><b>Remarks</b><br/>(R) Front Door, Molding - Scratch &amp; Dent - Small / Bonnet, Headlight - Scratch - Minimal / (L) Rear Fender, Molding - Scratch - Small</p> |
