## General Information

| Make | Nissan | Model | NV350 |
| YOM | 2020 | Odo Meter Reading | 76,839 |

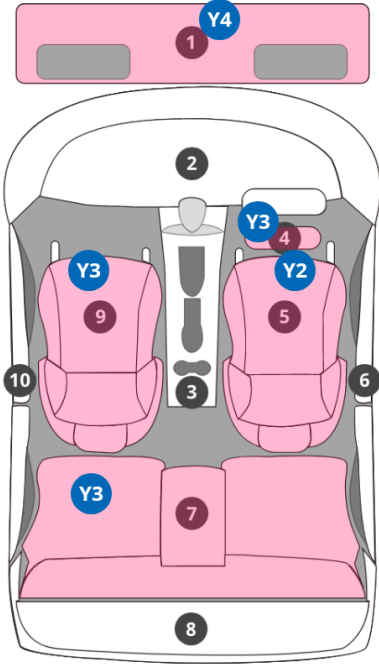
| Interior Evaluation : <b>C</b> | Exterior Evaluation : <b>D</b> |
| <b>Remarks</b><br>(L) Front Seat - Grime - Medium / (R) Front Seat - Grime - Small / (R) Front Floor Mat - Grime - Medium / Ceiling - Grime - Large / Rear Seat - Grime - Medium | <b>Remarks</b><br>(L) Front Door - Repair Traces - Yes / (L) Rear Fender - Repair Traces - Yes / Trunk Hood, Rear Gate - Repair Traces - Yes / Rear Bumper, Lamps, Panels - Scratch - Small / Trunk Hood, Rear Gate - Scratch - Small / (L) Rear Fender, Molding - Scratch - Medium / (L) Rear Door, Molding - Scratch & Dent - Small / (L) Front Door, Molding - Scratch - Small / (L) Mirror - Scratch - Small / (R) Front Fender, Molding - Scratch - Minimal / (R) Front Door, Molding - Scratch - Minimal / (R) Rear Door, Molding - Scratch & Dent - Medium / (R) Rear Fender, Molding - Scratch & Dent - Medium / Roof - Scratch - Small / Front Bumper, Grille, Lamps - Crack, Gap - Large |

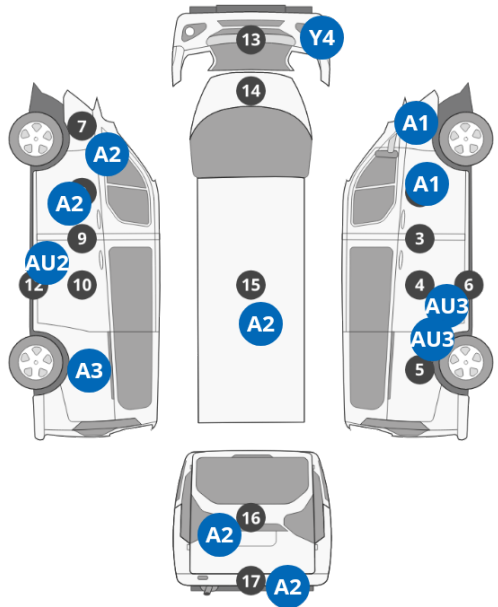
with LTO plate, no warranty booklet, incomplete tools, with jackm crack right frobt headlight. mufler is modified, possible flooding, missing knob of shift gear, hairline scratches in the body, replcaed mags,
