## General Information

| Make | Toyota | Model | Avanza |
| Registration No. | GAK5760 | Chassis No. | MHFAA1BY9N0010497 |

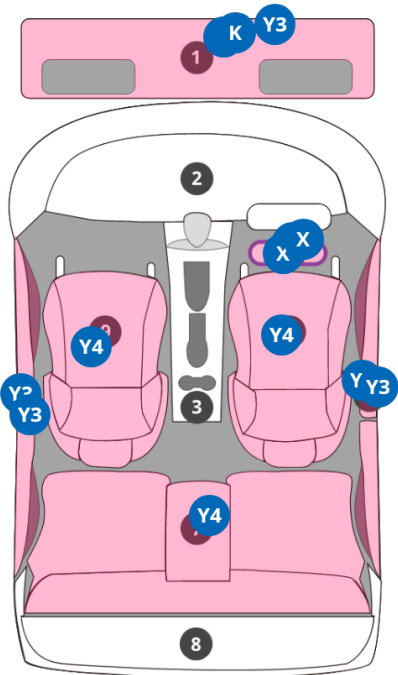
| Interior Evaluation : <b>E</b> | Exterior Evaluation : <b>E</b> |
|---|---|
| <b>Remarks</b><br>Overall Interior - Smell - Yes / Rear Seat - Grime - Large / (R) Rear Trim - Grime - Medium / (R) Front Floor Mat - Missing - Yes / (L) Front Floor Mat - Missing - Yes / Mat Other - Missing - Yes / (R) Front Seat - Grime - Large / (R) Front Trim - Grime - Medium / (L) Front Seat - Grime - Large / (L) Rear Trim - Grime - Medium / (L) Front Trim - Grime - Medium / Ceiling - Grime - Medium / Overall Interior - Animal Hair - Yes | <b>Remarks</b><br>(R) Front Door - Repair Traces - Yes / Bonnet - Repair Traces - Yes / (L) Front Door - Repair Traces - Yes / Front Bumper, Grille, Lamps - Scratch & Dent - Large / Bonnet, Headlight - Scratch - Medium / (L) Front Fender, Molding - Scratch & Dent - Medium / (L) Mirror - Scratch - Small / (L) Front Door, Molding - Scratch - Medium / (L) Rear Door, Molding - Scratch - Medium / (L) Rear Fender, Molding - Scratch - Small / Rear Bumper, Lamps, Panels - Scratch & Dent - Medium / Trunk Hood, Rear Gate - Scratch - Small / (R) Rear Fender, Molding - Scratch - Medium / (R) Rear Door, Molding - Scratch - Large / (R) Front Door, Molding - Scratch - Medium / (R) Step, In-panel, Side Spoiler - Scratch - Small / (L) Step, In-panel, Side Spoiler - Scratch - Small / (R) Mirror - Scratch - Medium / (R) Front Fender, Molding - Scratch - Small |
