## General Information

| Make | Toyota | Model | Raize |
| Registration No. | GBA3348 | Chassis No. | MHKAB1BA5PJ060117 |

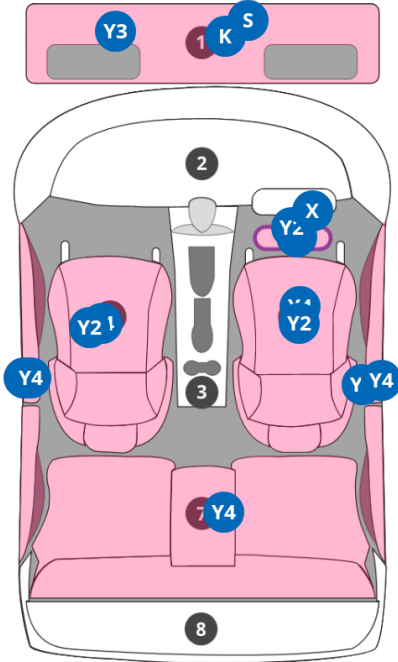
| Interior Evaluation : <b>E</b> | Exterior Evaluation : <b>D</b> |
|---|---|
| <p><b>Remarks</b></p> <p>(R) Front Floor Mat - Missing - Yes / (L) Front Floor Mat - Grime - Small / Mat Other - Missing - Yes / (R) Front Seat - Grime - Large / (R) Front Trim - Grime - Large / (R) Rear Trim - Grime - Large / Rear Seat - Grime - Large / (L) Rear Trim - Grime - Large / (L) Front Trim - Grime - Large / (L) Front Seat - Grime - Large / Overall Interior - Smell - Yes / Overall Interior - Animal Hair - Yes / (L) Front Seat belt - Grime - Small / (R) Front Seat belt - Grime - Small / Ceiling - Grime - Medium</p> | <p><b>Remarks</b></p> <p>Bonnet, Headlight - Scratch - Small / Front Bumper, Grille, Lamps - Scratch - Small / (R) Front Fender, Molding - Scratch - Small / (R) Mirror - Scratch - Minimal / (R) Front Door, Molding - Scratch - Small / (R) Rear Door, Molding - Scratch - Small / (R) Step, In-panel, Side Spoiler - Scratch - Small / (R) Rear Fender, Molding - Scratch - Minimal / Rear Bumper, Lamps, Panels - Scratch - Large / Trunk Hood, Rear Gate - Scratch - Minimal / (L) Rear Fender, Molding - Scratch - Small / (L) Rear Door, Molding - Scratch &amp; Dent - Medium / (L) Front Door, Molding - Scratch - Large / (L) Step, In-panel, Side Spoiler - Scratch - Small / (L) Mirror - Scratch - Minimal</p> |
