## General Information

| Make | Toyota | Model | Vios |

## Body / Panel Condition

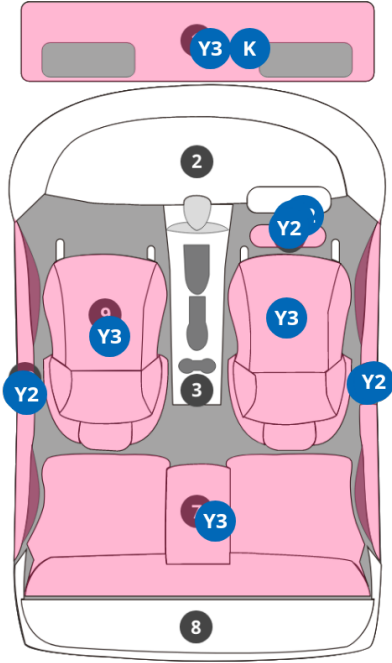
| Interior Evaluation : <span style="color: red;">C</span> | Exterior Evaluation : <span style="color: red;">E</span> |
| <b>Remarks</b><br>(R) Front Floor Mat - Grime - Small / (L) Front Floor Mat - Grime - Small / Ceiling - Grime - Medium / Mat Other - Grime - Small / (R) Front Trim - Grime - Small / Overall Interior - Animal Hair - Yes / (R) Front Seat - Grime - Medium / Rear Seat - Grime - Medium / (R) Rear Trim - Grime - Small / (L) Rear Trim - Grime - Minimal / (L) Front Trim - Grime - Small / (L) Front Seat - Grime - Medium | <b>Remarks</b><br>Bonnet, Headlight - Scratch - Medium / Front Bumper, Grille, Lamps - Scratch - Large / (R) Front Fender, Molding - Dent - Large / (R) Mirror - Scratch - Minimal / (R) Front Door, Molding - Scratch - Large / (R) Rear Door, Molding - Scratch - Large / (R) Step, In-panel, Side Spoiler - Scratch - Medium / (R) Rear Fender, Molding - Scratch - Medium / Rear Bumper, Lamps, Panels - Scratch - Large / Trunk Hood, Rear Gate - Scratch - Minimal / (L) Rear Fender, Molding - Scratch & Dent - Medium / (L) Rear Door, Molding - Scratch - Large / (L) Front Door, Molding - Scratch - Medium / (L) Mirror - Scratch - Medium / (L) Step, In-panel, Side Spoiler - Scratch - Medium |
