## General Information

| Make | Toyota | Model | Wigo |
| Registration No. | GBL1295 | Chassis No. | MHKAA1BC8SJ046399 |

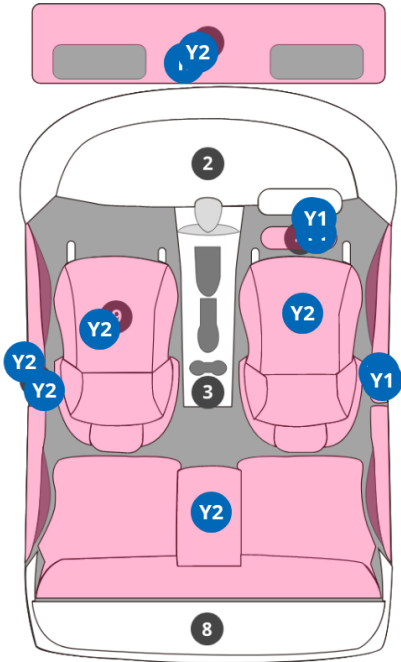
| Interior Evaluation : <b>B</b> | Exterior Evaluation : <b>E</b> |
| <b>Remarks</b><br>(R) Front Seat - Grime - Small / (R) Front Trim - Grime - Minimal / (R) Rear Trim - Grime - Minimal / (R) Front Floor Mat - Grime - Minimal / Rear Seat - Grime - Small / (L) Front Seat - Grime - Small / (L) Rear Trim - Grime - Small / (L) Front Trim - Grime - Small / Overall Interior - Animal Hair - Yes / Ceiling - Grime - Small / (L) Front Floor Mat - Grime - Minimal / Mat Other - Grime - Minimal | <b>Remarks</b><br>Front Bumper, Grille, Lamps - Scratch & Dent - Large / Bonnet, Headlight - Scratch - Small / (R) Front Fender, Molding - Scratch - Minimal / (R) Front Door, Molding - Scratch - Medium / (R) Rear Door, Molding - Scratch & Dent - Large / (R) Step, In-panel, Side Spoiler - Scratch - Large / (R) Rear Fender, Molding - Scratch & Dent - Large / Rear Bumper, Lamps, Panels - Scratch - Medium / Trunk Hood, Rear Gate - Scratch - Minimal / (L) Rear Fender, Molding - Scratch - Minimal / (L) Rear Door, Molding - Scratch - Medium / (L) Step, In-panel, Side Spoiler - Scratch - Small / (L) Front Door, Molding - Scratch - Large / (L) Mirror - Scratch - Minimal / (R) Mirror - Scratch - Minimal |

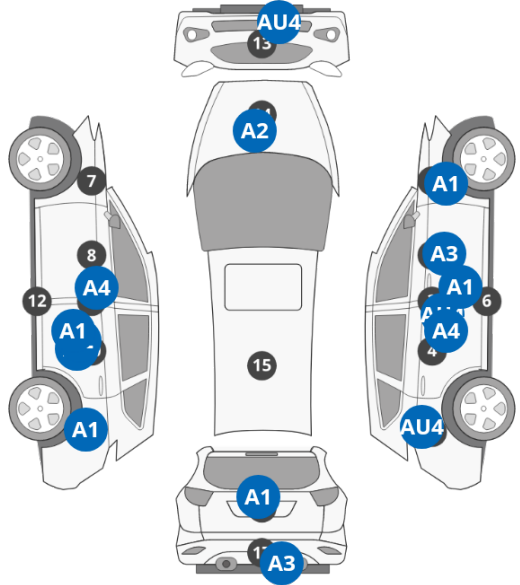
Audio Radio and Back Camera cannot fully function due to password lock. Visible hairline scratches. Incomplete tools. Without warranty booklet. With jack, sparetire, seatcover, LTO plate and 1key.
