## General Information

| Make | Toyota | Model | Vios |
| Registration No. | NEY3197 | Chassis No. | PA1B18F36R4254781 |

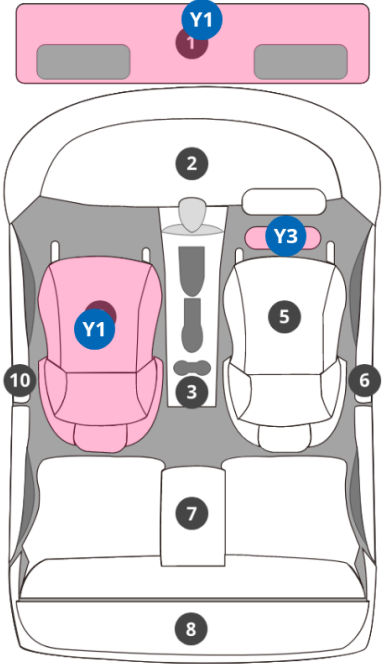
| <b>Remarks</b><br>(R) Front Floor Mat - Grime - Medium / (L) Front Seat - Grime - Minimal / Ceiling - Grime - Minimal | <b>Remarks</b><br>(R) Mirror - Scratch - Small / (R) Front Door, Molding - Scratch & Dent - Large / (R) Rear Door, Molding - Scratch - Large / Trunk Hood, Rear Gate - Scratch - Minimal / (R) Rear Fender, Molding - Scratch - Small / Rear Bumper, Lamps, Panels - Scratch - Medium / (L) Rear Fender, Molding - Scratch - Small / (L) Rear Door, Molding - Scratch - Minimal / (L) Front Door, Molding - Scratch - Minimal / (L) Front Fender, Molding - Scratch & Dent - Medium / Front Bumper, Grille, Lamps - Scratch - Medium / Bonnet, Headlight - Scratch - Medium |

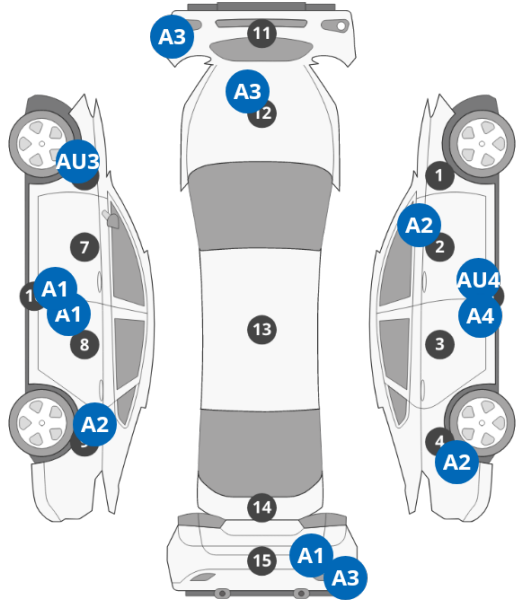
| Inspector Notes |
|---|
| no warranty booklet, with jack and tools, with spare tire, with LTO plate, crack on left tail light, handwriting on steering wheel |
