## General Information

| Make | Toyota | Model | Hilux Tamaraw |
| Registration No. | FAT8131 | Chassis No. | PAHACACA3S6424462 |

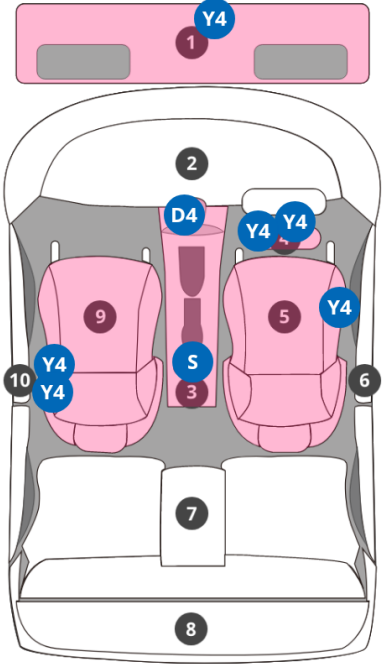
| Interior Evaluation : <span style="color: red; font-weight: bold;">E</span> | Exterior Evaluation : <span style="color: red; font-weight: bold;">E</span> |
| <p><b>Remarks</b><br/>Ceiling - Grime - Large / (L) Front Seat - Grime - Large / (L) Front Seat belt - Grime - Large / Overall Interior - Smell - Yes / (R) Front Seat - Grime - Large / Console, Switchs, Vents - Worked - Large / (R) Front Floor Mat - Grime - Large / (L) Front Floor Mat - Grime - Large</p> | <p><b>Remarks</b><br/>(R) Front Fender, Molding - Repair mark - Difference in Color / (R) Front Fender, Molding - Scratch &amp; Dent - Large / (R) Front Door, Molding - Dent - Large / (R) Mirror - Crack - Damaged / (R) Step, In-panel, Side Spoiler - Repair mark - Difference in Color / (R) Side Gate - Scratch - Large / Cargo Bed Floor - Rust, Corrosion - Large / Rear Gate - Scratch &amp; Dent - Medium / (L) Side Gate - Scratch - Large / (L) Front Door, Molding - Dent - Small / (L) Front Fender, Molding - Dent - Medium / Front Bumper, Grille, Lamps - Scratch &amp; Dent - Large / Bonnet, Headlight - Dent - Small</p> |
