## General Information

| Make | Toyota | Model | Hilux |

## Body / Panel Condition

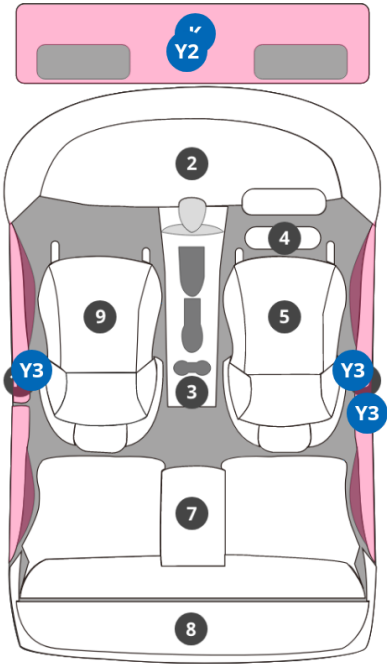
| <b>Interior Evaluation :</b> <span style="color: red; font-weight: bold;">B</span> | <b>Exterior Evaluation :</b> <span style="color: red; font-weight: bold;">E</span> |
| <b>Remarks</b><br>Overall Interior - Animal Hair - Yes / Ceiling - Grime - Small / (R) Front Trim - Grime - Medium / (R) Rear Trim - Grime - Medium / (L) Front Trim - Grime - Medium | <b>Remarks</b><br>(R) Front Door - Repair Traces - Yes / (R) Step - Repair Traces - Yes / (L) Front Door - Repair Traces - Yes / (L) Step - Repair Traces - Yes / (L) Rear Door - Repair Traces - Yes / (R) Rear Door - Repair Traces - Yes / Bonnet, Headlight - Scratch & Dent - Minimal / (R) Front Fender, Molding - Scratch & Dent - Large / (R) Front Door, Molding - Scratch & Dent - Minimal / (R) Side Gate - Scratch & Dent - Large / (R) Rear Corner Panel - Scratch & Dent - Medium / (R) Rear Door, Molding - Scratch - Medium / Rear Gate - Dent - Medium / (L) Side Gate - Scratch & Dent - Medium / (L) Rear Corner Panel - Scratch & Dent - Small / (L) Step, In-panel, Side Spoiler - Scratch - Medium / (L) Front Door, Molding - Scratch - Small / (L) Front Fender, Molding - Scratch - Medium / Front Bumper, Grille, Lamps - Scratch & Dent - Large / (L) Mirror - Crack - Damaged / Roof - Dent - Minimal / Rear Bumper, Lamps, Panels - Scratch & Dent - Medium / (L) Front Wheel, Cover - Cap Missing - Yes |
