## General Information

| Make | Toyota | Model | Hilux Tamaraw |
| Registration No. | DBU1217 | Chassis No. | PAHACACA2S6423643 |

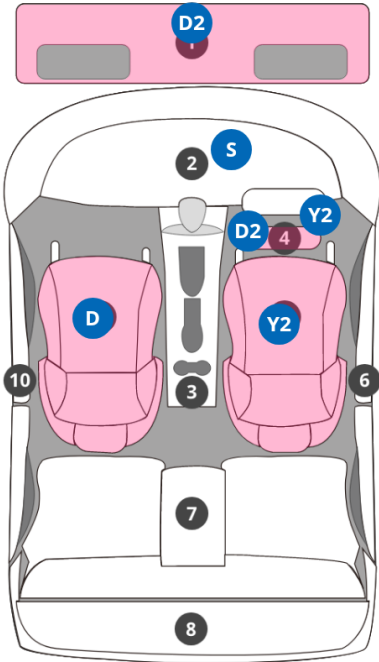
| Interior Evaluation : <b>B</b> | Exterior Evaluation : <b>D</b> |
| <b>Remarks</b><br>Overall Interior - Smell - Yes / (R) Front Seat - Grime - Small / (R) Front Floor Mat - Grime - Small / (L) Front Floor Mat - Worked - Small / (L) Front Seat - Worn - Yes / Ceiling - Crinkle - Small | <b>Remarks</b><br>(R) Mirror - Scratch - Small / (R) Front Fender, Molding - Scratch - Minimal / (R) Front Door, Molding - Scratch & Dent - Minimal / (R) Step, In-panel, Side Spoiler - Scratch - Small / (R) Side Gate - Scratch & Dent - Medium / Rear Bumper, Lamps, Panels - Scratch - Medium / Rear Gate - Scratch - Small / Cargo Bed Floor - Scratch - Large / (L) Side Gate - Scratch - Medium / (L) Step, In-panel, Side Spoiler - Scratch - Small / (L) Front Door, Molding - Scratch - Small / (L) Mirror - Scratch - Minimal / (L) Front Fender, Molding - Scratch - Minimal / Bonnet, Headlight - Scratch - Minimal / Front Bumper, Grille, Lamps - Scratch - Small / Roof - Scratch & Dent - Small |

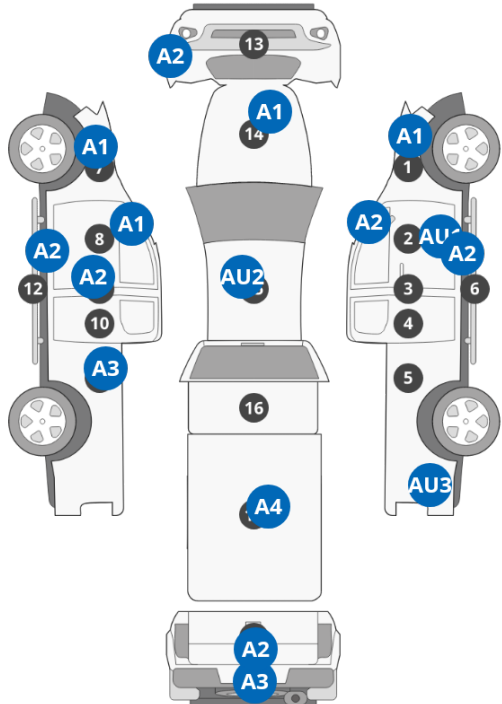
with LTO plate/with warranty booklet/with incomplete tools with jack/with spare tire/rear aircon vent missing/hairline scratches on the body/no reverse camera/no spare key
