## General Information

| Make | Toyota | Model | Innova |
| YOM | 2024 | Mileage | 20,311 |
| Registration No. | NKB8724 | Chassis No. | PA2JA8EM2P0133039 |

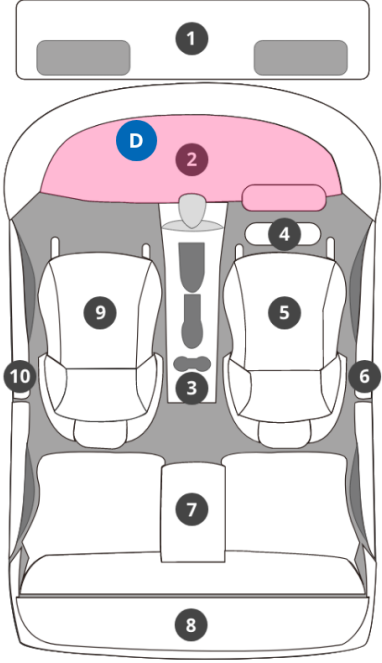
| <b>Interior Evaluation :</b> <span style="color: red; font-weight: bold;">A</span> | <b>Exterior Evaluation :</b> <span style="color: red; font-weight: bold;">C</span> |
| <b>Remarks</b><br>Dashboard - Traces of Adhesive Tape - Yes | <b>Remarks</b><br>Front Bumper, Grille, Lamps - Scratch - Medium / (L) Mirror - Scratch - Minimal / (L) Rear Door, Molding - Scratch - Medium / Rear Bumper, Lamps, Panels - Scratch - Medium / (R) Rear Fender, Molding - Scratch - Medium / (R) Rear Door, Molding - Scratch - Minimal / (R) Front Door, Molding - Scratch - Medium / (R) Rear Wheel, Cover - Scratch, Corrosion - Small / (R) Front Wheel, Cover - Scratch, Corrosion - Small |
