## General Information

| Make | Toyota | Model | Vios |

## Body / Panel Condition

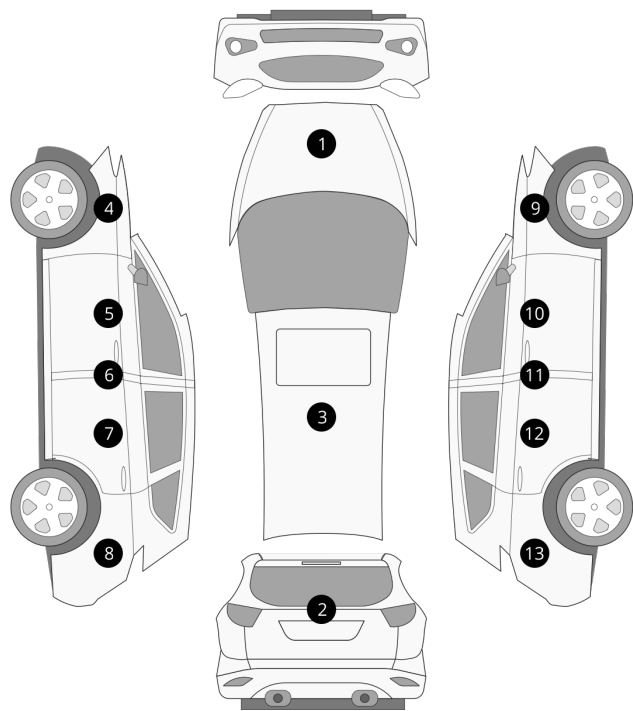
| # | Area | Thickness(um) | | | |
| 4 | Left Front Fender | 240.6 | 226 | 235 | 261 |
| 13 | Right Back Panel | 128.6 | 129 | 125 | 132 |

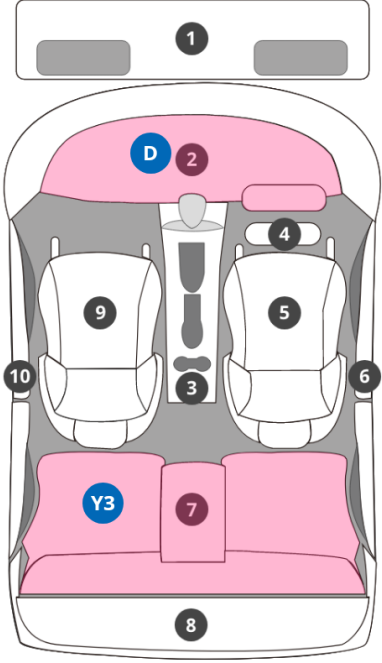
| <b>Interior Evaluation :</b> <b>B</b> | <b>Exterior Evaluation :</b> <b>B</b> |
| <b>Remarks</b><br>Dashboard - Traces of Adhesive Tape - Yes / Rear Seat - Grime - Medium | <b>Remarks</b><br>(L) Front Fender - Repair Traces - Yes / Bonnet, Headlight - Scratch & Dent - Small / Trunk Hood, Rear Gate - Dent - Minimal / (L) Front Door, Molding - Scratch - Medium / (R) Mirror - Scratch - Minimal / (R) Front Door, Molding - Scratch & Dent - Minimal / (R) Rear Fender, Molding - Scratch & Dent - Minimal / Rear Bumper, Lamps, Panels - Scratch - Small / (L) Rear Fender, Molding - Scratch - Small / (L) Rear Door, Molding - Scratch & Dent - Minimal / Front Bumper, Grille, Lamps - Scratch - Medium |
