## General Information

| Make | Toyota | Model | Vios |

## Body / Panel Condition

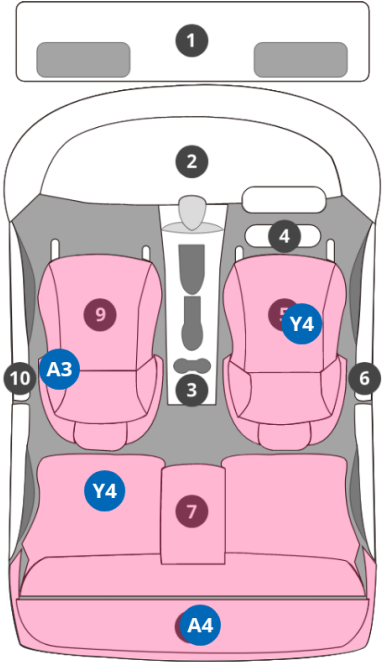
| Interior Evaluation : <span style="color: red;">C</span> | Exterior Evaluation : <span style="color: red;">E</span> |
| <b>Remarks</b><br>(L) Front Seat - Cut, Crack - Medium / Rear Seat - Grime - Large / Trunk Room - Worn, Scratch, Cut, Crack - Large / (R) Front Seat - Grime - Large / Overall Interior - Worn as per age - Yes | <b>Remarks</b><br>(R) Front Fender - Repair Traces - Yes / (L) Front Fender - Repair Traces - Yes / (L) Rear Door, Molding - Scratch & Dent - Large / (L) Step, In-panel, Side Spoiler - Scratch & Dent - Medium / (L) Rear Fender, Molding - Scratch & Dent - Large / Trunk Hood, Rear Gate - Scratch & Dent - Medium / Rear Bumper, Lamps, Panels - Scratch - Large / (R) Rear Fender, Molding - Scratch - Small / (R) Rear Door, Molding - Scratch & Dent - Medium / (R) Step, In-panel, Side Spoiler - Scratch & Dent - Large / (R) Front Fender, Molding - Scratch & Dent - Medium / (R) Front Door, Molding - Scratch & Dent - Small / Front Bumper, Grille, Lamps - Scratch - Large / Bonnet, Headlight - Scratch & Dent - Minimal / Roof - Dent - Small / (L) Front Door, Molding - Dent - Small / Front Windshield - Damaged - Large |
