## General Information

| Make | Toyota | Model | Wigo |

## Body / Panel Condition

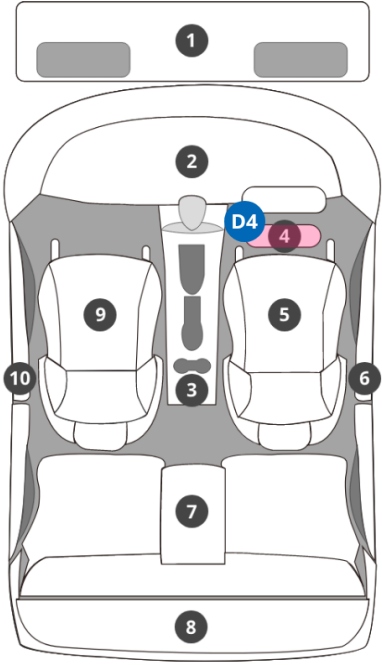
| Interior Evaluation : <span style="color: red;">C</span> | Exterior Evaluation : <span style="color: red;">E</span> |
| <b>Remarks</b><br>(L) Front Floor Mat - Worked - Large | <b>Remarks</b><br>Front Bumper, Grille, Lamps - Scratch - Large / (L) Front Fender, Molding - Scratch - Small / (L) Front Door, Molding - Scratch - Medium / Rear Bumper, Lamps, Panels - Scratch & Dent - Medium / (R) Rear Fender, Molding - Scratch - Medium / (R) Rear Door, Molding - Scratch - Large / (R) Step, In-panel, Side Spoiler - Scratch - Small / (R) Front Door, Molding - Repair mark - Difference in Color / (R) Front Fender, Molding - Repair mark - Difference in Color / (L) Rear Door, Molding - Scratch - Medium / (L) Step, In-panel, Side Spoiler - Scratch - Small |
