## General Information

| Make | Toyota | Model | Vios |
| YOM | 2025 | Odo Meter Reading | 34,786 |
| Registration No. | NEZ2272 | Chassis No. | PA1B18F38R4271534 |

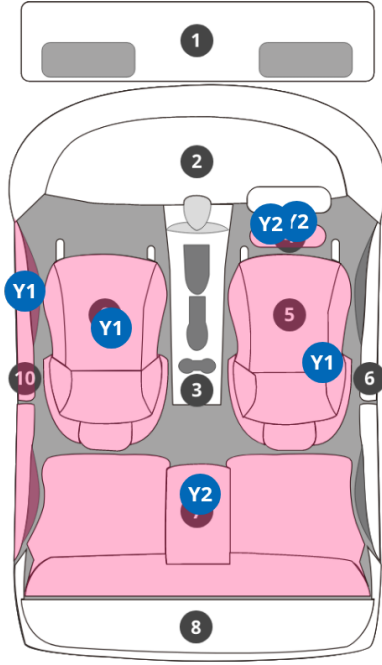
| Interior Evaluation : <b>A</b> | Exterior Evaluation : <b>C</b> |
| <b>Remarks</b><br>(L) Front Floor Mat - Grime - Small / (R) Front Floor Mat - Grime - Small / Rear Seat - Grime - Small / (L) Front Trim - Grime - Minimal / (L) Front Seat - Grime - Minimal / (R) Front Seat - Grime - Minimal | <b>Remarks</b><br>(R) Front Fender - Repair Traces - Yes / Bonnet - Repair Traces - Yes / (L) Front Fender - Repair Traces - Yes / Roof - Scratch & Dent - Minimal / (L) Front Door, Molding - Scratch & Dent - Minimal / (L) Rear Door, Molding - Scratch & Dent - Minimal / (L) Rear Fender, Molding - Scratch - Small / Trunk Hood, Rear Gate - Scratch & Dent - Minimal / Rear Bumper, Lamps, Panels - Scratch - Small / (R) Rear Fender, Molding - Scratch & Dent - Minimal / (R) Rear Door, Molding - Scratch & Dent - Medium / (R) Front Door, Molding - Scratch - Small / (R) Step, In-panel, Side Spoiler - Scratch - Small / (R) Front Fender, Molding - Scratch & Dent - Minimal / Bonnet, Headlight - Scratch & Dent - Minimal / Front Bumper, Grille, Lamps - Scratch - Small / (L) Front Fender, Molding - Scratch & Dent - Minimal |

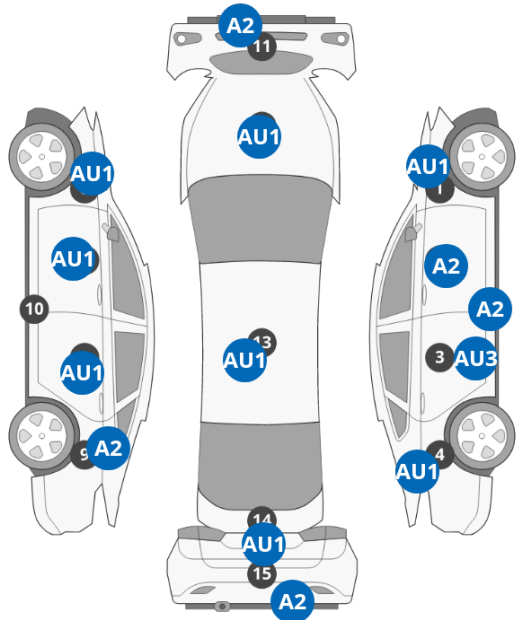
| Inspector Notes |
|---|
| with LTO plate, with spare tire, with jack and inc tools, with reverse camera, with warranty booklet, no spare key, no manual booklet, scratches on taillight and headlight, minor scratches on exterior, issue on plate light. |
