## General Information

| Make | Toyota | Model | Hilux Tamaraw |
| Registration No. | NEZ9461 | Chassis No. | PAHACACA1S6431264 |

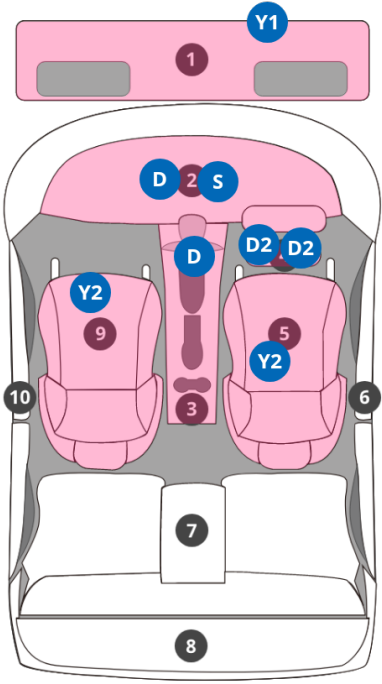
| Interior Evaluation : <b>B</b> | Exterior Evaluation : <b>C</b> |
| <b>Remarks</b><br>Dashboard - Traces of Adhesive Tape - Yes / Console, Switchs, Vents - Traces of Adhesive Tape - Yes / Ceiling - Grime - Minimal / (L) Front Seat - Grime - Small / (R) Front Seat - Grime - Small / (L) Front Floor Mat - Worked - Small / (R) Front Floor Mat - Worked - Small / Overall Interior - Smell - Yes | <b>Remarks</b><br>(R) Front Fender, Molding - Scratch - Small / (R) Mirror - Scratch - Minimal / (R) Front Door, Molding - Scratch - Minimal / (R) Side Gate - Scratch - Minimal / Rear Gate - Scratch - Minimal / Cargo Bed Floor - Scratch - Large / (L) Mirror - Scratch - Minimal / (L) Front Door, Molding - Scratch - Minimal / (L) Side Gate - Scratch - Minimal / Front Bumper, Grille, Lamps - Scratch - Minimal / (L) Front Fender, Molding - Scratch - Minimal / Roof - Scratch - Minimal |
