## General Information

| Make | Toyota | Model | Vios |

## Body / Panel Condition

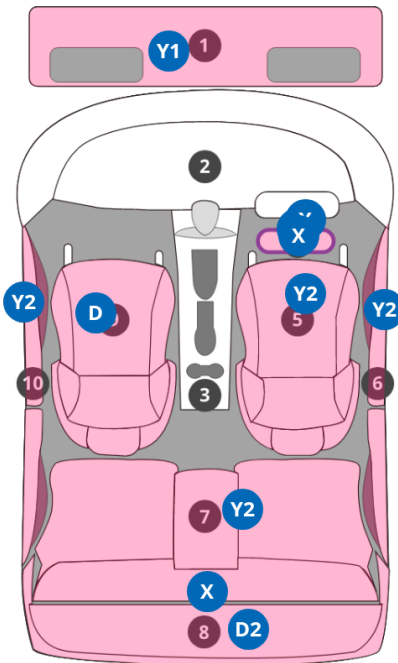
| <b>Interior Evaluation :</b> <b>B</b> | <b>Exterior Evaluation :</b> <b>E</b> |
| <b>Remarks</b><br>(L) Front Floor Mat - Missing - Yes / (R) Front Floor Mat - Missing - Yes / Mat Other - Missing - Yes / (R) Front Seat - Grime - Small / (L) Front Seat - Worn - Yes / Rear Seat - Grime - Small / (L) Front Trim - Grime - Small / (R) Front Trim - Grime - Small / Ceiling - Grime - Minimal / Trim Other - Missing - Yes / Trunk Room - Loose, Deformed - Small | <b>Remarks</b><br>(R) Front Door - Repair Traces - Yes / (R) Step - Repair Traces - Yes / (R) Front Fender - Repair Traces - Yes / Bonnet - Repair Traces - Yes / (L) Front Fender - Repair Traces - Yes / (L) Front Door - Repair Traces - Yes / (L) Rear Door - Repair Traces - Yes / (L) Rear Fender - Repair Traces - Yes / Trunk Hood, Rear Gate - Repair Traces - Yes / Overall Exterior - Re-Paint Uneven - Yes / (L) Rear Door, Molding - Scratch & Dent - Small / (L) Rear Fender, Molding - Scratch & Dent - Small / Rear Bumper, Lamps, Panels - Scratch & Dent - Large / Trunk Hood, Rear Gate - Scratch & Dent - Small / Trunk Hood, Rear Gate - Repair mark - Yes / Rear Bumper, Lamps, Panels - Repair mark - Yes / (R) Rear Fender, Molding - Scratch & Dent - Minimal / (R) Rear Fender, Molding - Repair mark - Yes / (R) Rear Door, Molding - Repair mark - Yes / (R) Rear Door, Molding - Scratch & Dent - Minimal / (R) Front Door, Molding - Scratch & Dent - Small / (R) Step, In-panel, Side Spoiler - Scratch & Dent - Small / Roof - Scratch & Dent - Small / (R) Front Fender, Molding - Scratch - Medium / (R) Front Fender, Molding - Repair mark - Yes / (R) Front Door, Molding - Repair mark - Yes / Bonnet, Headlight - Scratch & Dent - Small / Front Bumper, Grille, Lamps - Repair mark - Difference in Color / Front Bumper, Grille, Lamps - Modified - Medium / (L) Front Fender, Molding - Scratch - Medium / (L) Front Door, Molding - Scratch & Dent - Small / (L) Step, In-panel, Side Spoiler - Scratch & Dent - Small |
