## General Information

| Make | Toyota | Model | Vios |
| Registration No. | NKE1085 | Chassis No. | PA1B18F3XR4257229 |

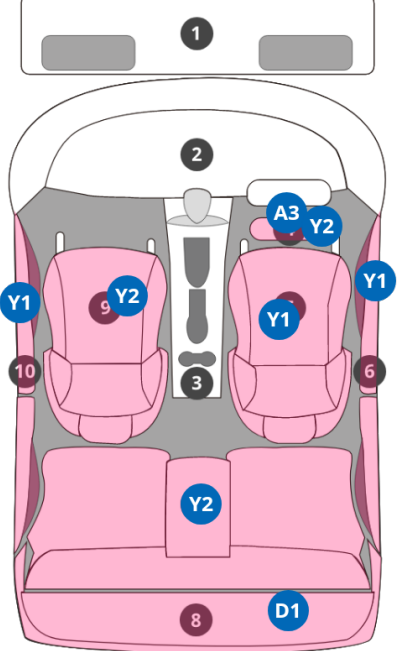
| Interior Evaluation : <b>B</b> | Exterior Evaluation : <b>C</b> |
| <p><b>Remarks</b></p> <p>(L) Front Floor Mat - Cut, Crack - Medium / (R) Front Floor Mat - Grime - Small / Rear Seat - Grime - Small / (L) Front Seat - Grime - Small / (R) Front Seat - Grime - Minimal / (R) Front Trim - Grime - Minimal / (L) Front Trim - Grime - Minimal / Trunk Room - Worked - Minimal</p> | <p><b>Remarks</b></p> <p>(R) Front Door - Repair Traces - Yes / (R) Front Fender - Repair Traces - Yes / Bonnet - Repair Traces - Yes / (L) Front Fender - Repair Traces - Yes / Roof - Scratch - Small / (L) Rear Door, Molding - Scratch &amp; Dent - Small / (L) Rear Fender, Molding - Scratch &amp; Dent - Minimal / Trunk Hood, Rear Gate - Scratch - Small / (R) Rear Fender, Molding - Scratch - Small / (R) Rear Door, Molding - Scratch &amp; Dent - Small / (R) Front Door, Molding - Scratch &amp; Dent - Minimal / (R) Front Fender, Molding - Scratch &amp; Dent - Small / Bonnet, Headlight - Scratch &amp; Dent - Minimal / Front Bumper, Grille, Lamps - Scratch - Medium / (L) Front Fender, Molding - Scratch &amp; Dent - Minimal / (L) Front Door, Molding - Scratch - Small / (L) Step, In-panel, Side Spoiler - Scratch - Minimal</p> |

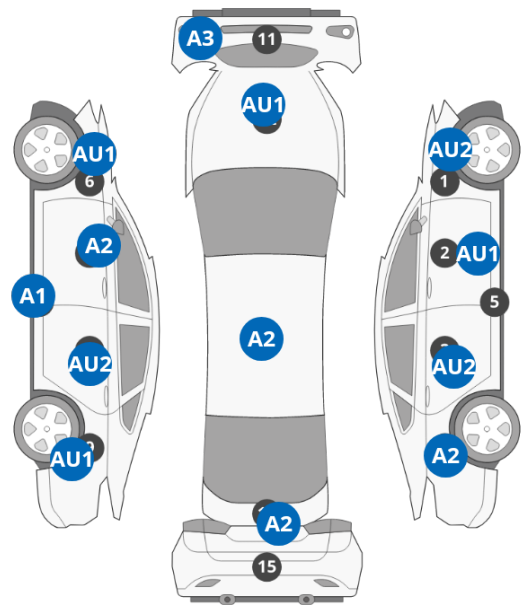
| Inspector Notes |
|---|
| <p>only one LTO plate, with spare tire and key, with warranty and manual booklet, with jack, no tools, scratches and dent on exterior, scratches on taillight and headlight.</p> |
