## General Information

| Make | Toyota | Model | Vios |
| Registration No. | NIU7143 | Chassis No. | PA1B18F32R4243969 |

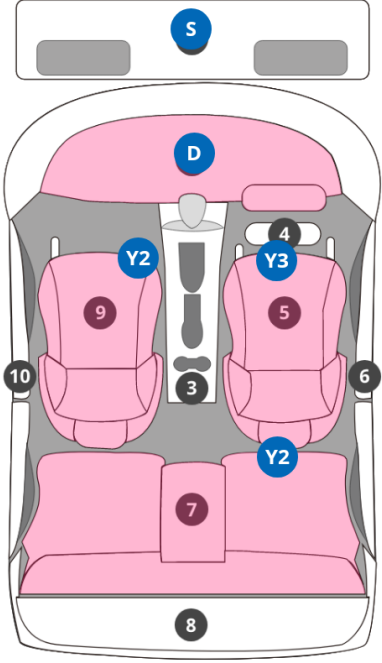
| <b>Remarks</b><br>Dashboard - Traces of Adhesive Tape - Yes / Overall Interior - Smell - Yes / (R) Front Seat - Grime - Medium / Rear Seat - Grime - Small / (L) Front Seat - Grime - Small | <b>Remarks</b><br>Trunk Hood, Rear Gate - Repair Traces - Yes / Rear Bumper, Lamps, Panels - Scratch & Dent - Large / Roof - Dent - Small / Bonnet, Headlight - Dent - Small / (R) Rear Fender, Molding - Dent - Minimal / Front Bumper, Grille, Lamps - Scratch - Small / (R) Mirror - Scratch - Small / (R) Front Door, Molding - Scratch - Medium / (L) Front Door, Molding - Scratch & Dent - Minimal / (L) Rear Fender, Molding - Scratch & Dent - Large / Trunk Hood, Rear Gate - Scratch & Dent - Large |

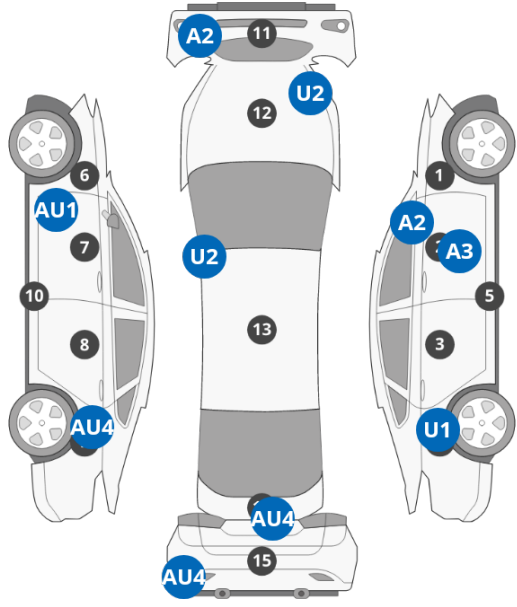
| Inspector Notes |
|---|
| crack left taillight. with warranty booklet and spare tire. without tools and jack. with LTO plate.gap at the left rear bumper. |
