## General Information

| Make | Kia | Model | Stonic |
| YOM | 2023 | Odo Meter Reading | 60,358 |
| Registration No. | FAO3197 | Chassis No. | LJD4AA19BP0111044 |

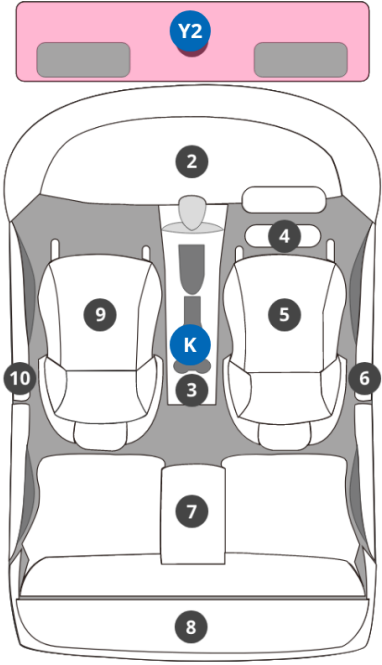
| Interior Evaluation : <b>B</b> | Exterior Evaluation : <b>E</b> |
|---|---|
| <p><b>Remarks</b><br/>Ceiling - Grime - Small / Overall Interior - Animal Hair - Yes</p> | <p><b>Remarks</b><br/>(L) Rear Door - Repair Traces - Yes / Trunk Hood, Rear Gate - Repair Traces - Yes / Front Bumper, Grille, Lamps - Crack, Gap - Large / (R) Front Door, Molding - Scratch &amp; Dent - Medium / (R) Rear Door, Molding - Scratch - Medium / Trunk Hood, Rear Gate - Dent - Large / Rear Bumper, Lamps, Panels - Scratch - Medium / (L) Rear Fender, Molding - Scratch &amp; Dent - Large / (L) Rear Door, Molding - Scratch - Small / (L) Front Door, Molding - Scratch - Small / (L) Step, In-panel, Side Spoiler - Scratch - Small / (L) Front Fender, Molding - Scratch - Minimal / Bonnet, Headlight - Scratch - Minimal</p> |
