## General Information

| Make | Toyota | Model | Vios |

## Body / Panel Condition

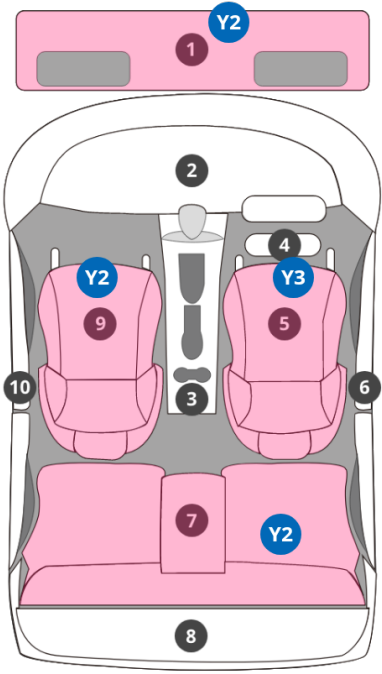
| Interior Evaluation : <b>B</b> | Exterior Evaluation : <b>B</b> |
| <p><b>Remarks</b><br/>Ceiling - Grime - Small / (L) Front Seat - Grime - Small / (R) Front Seat - Grime - Medium / Rear Seat - Grime - Small</p> | <p><b>Remarks</b><br/>(R) Front Door - Repair Traces - Yes / Bonnet - Repair Traces - Yes / (R) Mirror - Scratch, Peeled - Minimal / Rear Bumper, Lamps, Panels - Repair mark - Yes / Bonnet, Headlight - Dent - Minimal / (L) Mirror - Scratch, Peeled - Minimal / Front Bumper, Grille, Lamps - Scratch &amp; Dent - Medium / (R) Front Door, Molding - Repair mark - Yes / (L) Front Door, Molding - Scratch - Small / (L) Rear Door, Molding - Scratch - Minimal / (L) Rear Fender, Molding - Crack, Gap - Medium</p> |
