## General Information

| Make | Toyota | Model | Vios |

## Body / Panel Condition

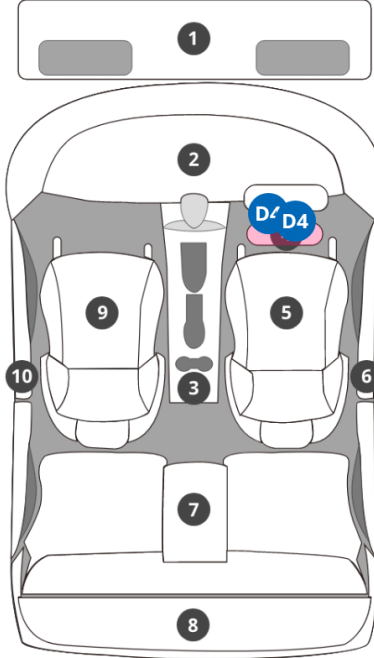
| Interior Evaluation : C | | Exterior Evaluation : C | |
|---|--|---|--|
| <p><b>a</b> : Cut, Fray <b>d</b> : Loose, Deformed <b>k</b> : Animal Hair <b>s</b> : Smell <b>t</b> : Cigarette Burns <b>x</b> : Defective <b>y</b> : Stain</p> | | <p><b>A</b> : Scratch <b>AU</b> : Scratch &amp; Dent <b>B</b> : Modified <b>C</b> : Corrosion <b>G</b> : Stone chip <b>P</b> : Faded <b>S</b> : Rust <b>SC</b> : Rust &amp; Corrosion <b>U</b> : Dent <b>X</b> : Defective <b>Y</b> : Crack, Gap</p> | |
| <p><b>Remarks</b></p> <p>(L) Front Floor Mat - Worked - Large / (R) Front Floor Mat - Worked - Large</p> | | <p><b>Remarks</b></p> <p>Front Bumper, Grille, Lamps - Crack, Gap - Large / (R) Front Fender, Molding - Scratch &amp; Dent - Medium / (R) Front Door, Molding - Scratch &amp; Dent - Small / (R) Step, In-panel, Side Spoiler - Scratch - Small / Rear Bumper, Lamps, Panels - Scratch - Small / Trunk Hood, Rear Gate - Dent - Minimal / (L) Step, In-panel, Side Spoiler - Scratch &amp; Dent - Medium / (L) Rear Door, Molding - Scratch &amp; Dent - Medium / Bonnet, Headlight - Crack, Gap - Small</p> | |
