## General Information

| Make | Toyota | Model | Vios |

## Body / Panel Condition

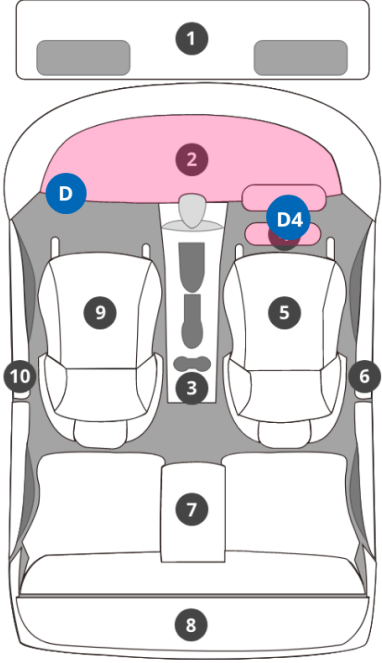
| <b>Interior Evaluation :</b> <span style="color: red; font-weight: bold;">C</span> | <b>Exterior Evaluation :</b> <span style="color: red; font-weight: bold;">C</span> |
| <b>Remarks</b><br>Mat Other - Worked - Large / (L) Front Floor Mat - Cut, Crack - Small / (L) Front Floor Mat - Worked - Large / Dashboard - Traces of Adhesive Tape - Yes | <b>Remarks</b><br>(R) Rear Door, Molding - Scratch - Small / (R) Step, In-panel, Side Spoiler - Scratch & Dent - Large / (R) Rear Fender, Molding - Scratch - Minimal / Roof - Scratch - Minimal / Rear Bumper, Lamps, Panels - Scratch - Small / (L) Front Fender, Molding - Scratch & Dent - Medium / (L) Mirror - Scratch - Small / Front Bumper, Grille, Lamps - Scratch - Medium / (L) Rear Door, Molding - Scratch & Dent - Medium / (L) Front Door, Molding - Scratch - Medium |
