## General Information

| Make | Toyota | Model | Veloz |

## Body / Panel Condition

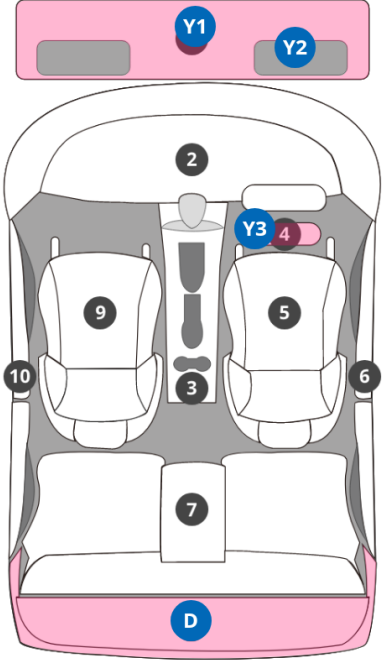
| Interior Evaluation : <b>B</b> | Exterior Evaluation : <b>A</b> |
| <b>Remarks</b><br>Ceiling - Grime - Minimal / Trunk Room - Traces of Adhesive Tape - Yes / (L) Front Floor Mat - Grime - Medium / Sunvisor, Sunglass Holder - Grime - Small | <b>Remarks</b><br>Bonnet, Headlight - Dent - Small / (L) Front Door, Molding - Scratch - Small |
