## General Information

| Make | Toyota | Model | Wigo |
| YOM | 2020 | Odo Meter Reading | 113,593 |
| Registration No. | NEK1617 | Chassis No. | MHKA4DF5FKJ034902 |

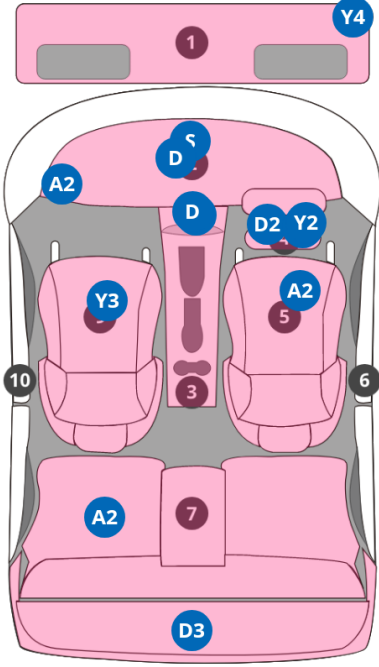
| Interior Evaluation : <b>D</b> | Exterior Evaluation : <b>E</b> |
|---|---|
| <p><b>a</b> : Cut, Fray <b>d</b> : Loose, Deformed <b>k</b> : Animal Hair <b>s</b> : Smell <b>t</b> : Cigarette Burns <b>x</b> : Defective <b>y</b> : Stain</p> | <p><b>A</b> : Scratch <b>AU</b> : Scratch &amp; Dent <b>B</b> : Modified <b>C</b> : Corrosion <b>G</b> : Stone chip <b>P</b> : Faded <b>S</b> : Rust <b>SC</b> : Rust &amp; Corrosion <b>U</b> : Dent <b>X</b> : Defective <b>Y</b> : Crack, Gap</p> |
| <p><b>Remarks</b></p> <p>Overall Interior - Smell - Yes / Overall Interior - Worn as per age - Yes / (L) Front Floor Mat - Worked - Small / Carpet - Worked - Large / Console, Switches, Vents - Worn, Scratch, Cut, Crack - Small / Dashboard - Traces of Adhesive Tape - Yes / (L) Front Seat - Grime - Medium / Rear Seat - Cut, Crack - Small / Ceiling - Grime - Large / (R) Front Floor Mat - Grime - Small / Trunk Room - Loose, Deformed - Medium / Dashboard - Worn, Scratch, Cut, Crack - Small / Console, Switches, Vents - Repair Mark - Yes</p> | <p><b>Remarks</b></p> <p>(L) Front Fender - Repair Traces - Yes / (R) Front Fender, Molding - Modified - Small / (R) Front Fender, Molding - Scratch &amp; Dent - Small / (R) Mirror - Scratch, Peeled - Yes / (R) Mirror - Faded(Color, Gloss) - Yes / (R) Mirror - Scratch - Small / Overall Exterior - Faded(Color, Gloss) - Yes / Overall Exterior - Worn as per age - Yes / (R) Step, In-panel, Side Spoiler - Scratch &amp; Dent - Large / (R) Rear Door, Molding - Scratch &amp; Dent - Medium / (R) Rear Fender, Molding - Scratch &amp; Dent - Medium / (R) Front Door, Molding - Scratch &amp; Dent - Large / Rear Bumper, Lamps, Panels - Crack, Gap - Large / Rear Bumper, Lamps, Panels - Repair mark - Yes / Trunk Hood, Rear Gate - Scratch &amp; Dent - Large / (L) Rear Fender, Molding - Scratch - Medium / (L) Rear Door, Molding - Scratch - Medium / (L) Front Door, Molding - Scratch &amp; Dent - Large / (L) Step, In-panel, Side Spoiler - Scratch &amp; Dent - Medium / (L) Mirror - Crack - Damaged / (L) Mirror - Faded(Color, Gloss) - Yes / (L) Mirror - Scratch - Small / (L) Front Fender, Molding - Modified - Small / Front Bumper, Grille, Lamps - Modified - Medium / (L) Front Fender, Molding - Scratch &amp; Dent - Large / Front Bumper, Grille, Lamps - Repair mark - Yes / Member (Bolted) - Dent - Yes / Front Bumper, Grille, Lamps - Scratch &amp; Dent - Large / Bonnet, Headlight - Scratch &amp; Dent - Medium / Roof - Scratch &amp; Dent - Large</p> |
