## General Information

| Make | Toyota | Model | Vios |
| YOM | 2021 | Odo Meter Reading | 67,728 |
| Registration No. | DAV8405 | Chassis No. | PA1B18F35M4151599 |

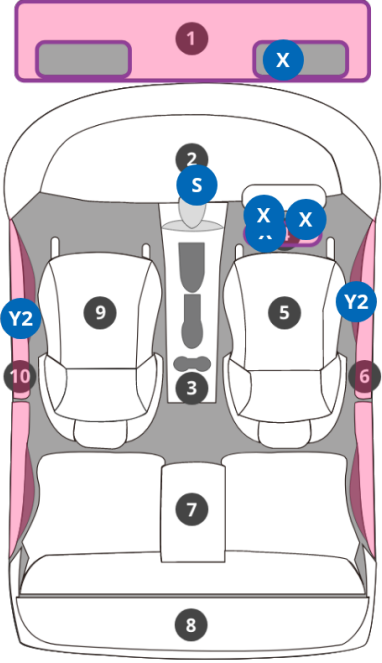
| Interior Evaluation : <b>B</b> | Exterior Evaluation : <b>E</b> |
| <p><b>Remarks</b><br/>(R) Front Floor Mat - Missing - Yes / (L) Front Floor Mat - Missing - Yes / Mat Other - Missing - Yes / Overall Interior - Smell - Yes / (L) Front Trim - Grime - Small / (R) Front Trim - Grime - Small / Sunvisor, Sunglass Holder - Missing - Yes</p> | <p><b>Remarks</b><br/>(R) Front Door, Molding - Scratch - Large / (R) Rear Door, Molding - Scratch &amp; Dent - Large / (R) Rear Fender, Molding - Scratch - Large / Rear Bumper, Lamps, Panels - Scratch &amp; Dent - Large / Trunk Hood, Rear Gate - Scratch - Small / (L) Mirror - Crack - Damaged / (L) Rear Fender, Molding - Scratch - Small / (L) Rear Door, Molding - Scratch - Small / (L) Front Door, Molding - Scratch - Small / Front Bumper, Grille, Lamps - Scratch &amp; Dent - Large / Bonnet, Headlight - Scratch - Large / (R) Mirror - Scratch - Small / (R) Step, In-panel, Side Spoiler - Scratch &amp; Dent - Large / (R) Front Fender, Molding - Scratch &amp; Dent - Small</p> |

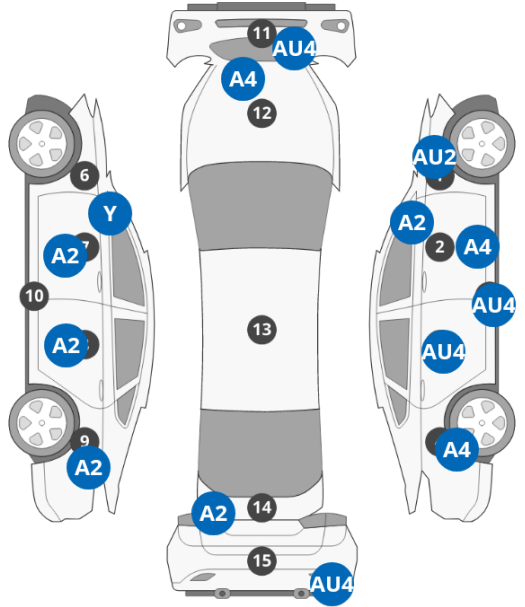
| Inspector Notes |
|---|
| no tools and jack, no spare tire and warranty booklet/ worn tires/no LTO plate/ possible flooding/ light scratches around the exterior/ horn issue/ side mirror issue/ |
