## General Information

| Make | Toyota | Model | Veloz |
| YOM | 2025 | Odo Meter Reading | 44,904 |
| Registration No. | DBS9972 | Chassis No. | MHFAB1BY0R3131355 |

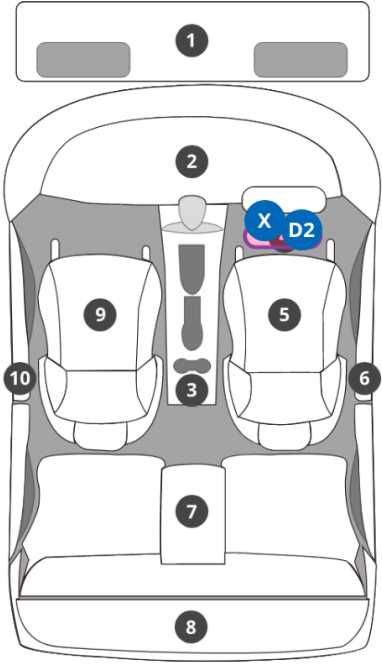
| Interior Evaluation : <b>B</b> | Exterior Evaluation : <b>C</b> |
|---|---|
| <b>Remarks</b><br>Mat Other - Worked - Small / (L) Front Floor Mat - Missing - Yes | <b>Remarks</b><br>Roof - Repair Traces - Yes / (R) Front Fender, Molding - Scratch - Minimal / (R) Mirror - Scratch - Minimal / (R) Front Door, Molding - Scratch & Dent - Minimal / (R) Rear Door, Molding - Scratch & Dent - Small / (R) Step, In-panel, Side Spoiler - Scratch - Minimal / (R) Rear Fender, Molding - Scratch - Minimal / Roof - Scratch - Minimal / Rear Bumper, Lamps, Panels - Scratch - Small / Trunk Hood, Rear Gate - Scratch & Dent - Medium / (L) Rear Fender, Molding - Scratch - Minimal / (L) Rear Door, Molding - Scratch & Dent - Minimal / (L) Step, In-panel, Side Spoiler - Scratch - Minimal / (L) Front Door, Molding - Scratch - Minimal / (L) Mirror - Scratch - Minimal / (L) Front Fender, Molding - Scratch - Minimal / Front Bumper, Grille, Lamps - Scratch & Dent - Large / Bonnet, Headlight - Scratch - Minimal |
