## General Information

| Make | Suzuki | Model | APV |
| Registration No. | NIP5165 | Chassis No. | 130123000097904 |

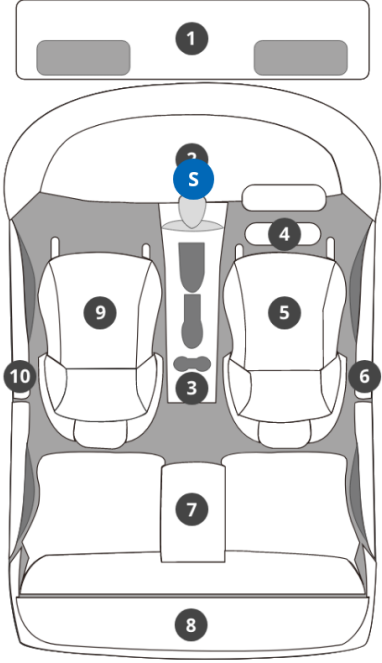
| Interior Evaluation : <span style="color: red; font-weight: bold;">A</span> | Exterior Evaluation : <span style="color: red; font-weight: bold;">C</span> |
| <b>Remarks</b><br>Defects not found | <b>Remarks</b><br>Trunk Hood, Rear Gate - Scratch - Small / Rear Bumper, Lamps, Panels - Scratch - Small / (L) Rear Door, Molding - Scratch - Small / (L) Front Fender, Molding - Scratch - Small / (L) Front Door, Molding - Scratch - Minimal / Front Bumper, Grille, Lamps - Scratch - Medium / (R) Front Door, Molding - Scratch & Dent - Small / (R) Rear Door, Molding - Scratch & Dent - Large |
