## General Information

| Make | Toyota | Model | Vios |
| Registration No. | DBF3941 | Chassis No. | PA1B18F32M4159711 |

## Body / Panel Condition

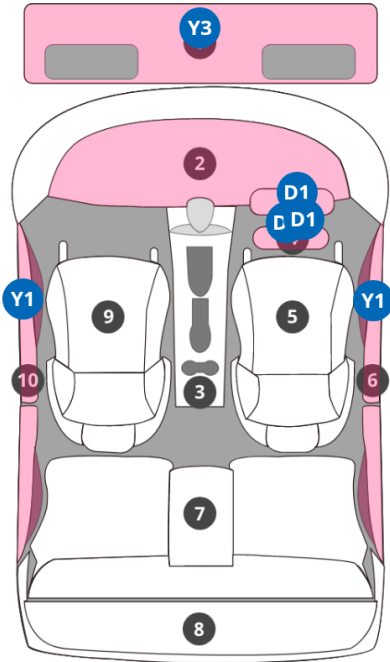
| Interior Evaluation : <b>B</b> | Exterior Evaluation : <b>E</b> |
| <b>Remarks</b><br>Ceiling - Grime - Medium / (R) Front Trim - Grime - Minimal / Glove Box - Worked - Minimal / (L) Front Trim - Grime - Minimal / (L) Front Floor Mat - Worked - Small / Carpet - Worked - Minimal | <b>Remarks</b><br>(R) Front Fender, Molding - Scratch - Minimal / (R) Front Tyre - Crack, Cut - Yes / (R) Mirror - Scratch - Minimal / (R) Front Door, Molding - Scratch - Minimal / (R) Rear Door, Molding - Scratch & Dent - Large / (R) Step, In-panel, Side Spoiler - Scratch & Dent - Large / (R) Rear Fender, Molding - Scratch & Dent - Minimal / Rear Bumper, Lamps, Panels - Scratch & Dent - Medium / Trunk Hood, Rear Gate - Scratch - Minimal / (L) Rear Fender, Molding - Scratch - Minimal / (L) Rear Door, Molding - Scratch & Dent - Medium / (L) Front Door, Molding - Scratch & Dent - Minimal / (L) Mirror - Scratch - Minimal / (L) Step, In-panel, Side Spoiler - Scratch - Minimal / (L) Front Fender, Molding - Scratch - Minimal / Front Bumper, Grille, Lamps - Crack, Gap - Medium / Bonnet, Headlight - Scratch - Minimal |
