## General Information

| Make | Toyota | Model | Hilux |

## Body / Panel Condition

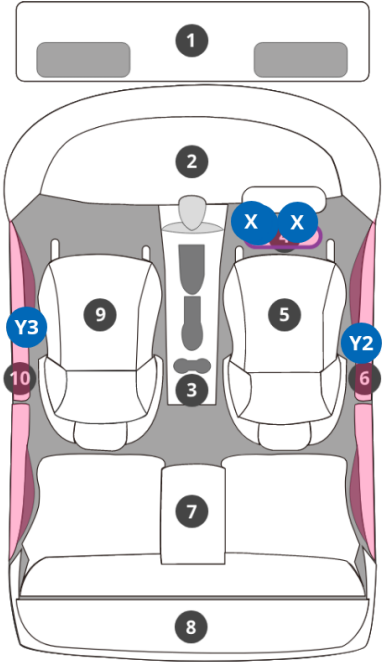
| Interior Evaluation : <b>B</b> | Exterior Evaluation : <b>E</b> |
| <b>Remarks</b><br>(L) Front Trim - Grime - Medium / (R) Front Trim - Grime - Small / (R) Front Floor Mat - Missing - Yes / (L) Front Floor Mat - Missing - Yes / Mat Other - Missing - Yes | <b>Remarks</b><br>(L) Side Gate - Dent - Small / (L) Rear Door, Molding - Dent - Small / (L) Front Door, Molding - Scratch & Dent - Small / Bonnet, Headlight - Scratch - Large / Front Windshield - Damaged - Large / Front Bumper, Grille, Lamps - Scratch & Dent - Large / (R) Front Fender, Molding - Scratch - Minimal / (R) Front Door, Molding - Dent - Small / (R) Rear Door, Molding - Scratch - Small / (R) Side Gate - Scratch & Dent - Large / Rear Bumper, Lamps, Panels - Scratch - Medium / Rear Gate - Dent - Small |
