## General Information

| Make | Toyota | Model | Vios |

## Body / Panel Condition

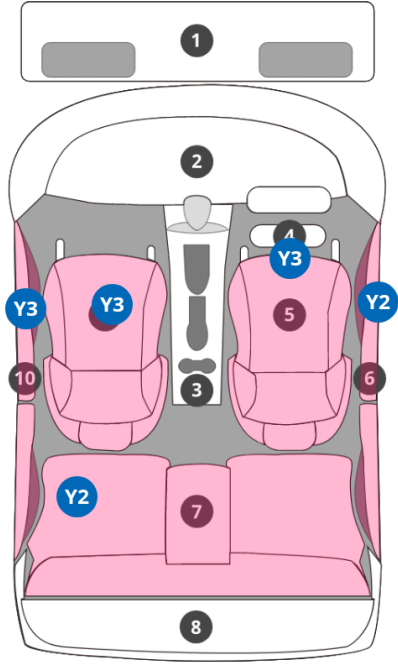
| Interior Evaluation : <b>B</b> | Exterior Evaluation : <b>E</b> |
|---|---|
| <p><b>Remarks</b><br/>(L) Front Trim - Grime - Medium / (L) Front Seat - Grime - Medium / Rear Seat - Grime - Small / (R) Front Seat - Grime - Medium / (R) Front Trim - Grime - Small</p> | <p><b>Remarks</b><br/>(L) Front Door, Molding - Scratch &amp; Dent - Small / Front Bumper, Grille, Lamps - Scratch &amp; Dent - Large / Bonnet, Headlight - Scratch - Small / (R) Front Fender, Molding - Scratch - Small / (R) Front Door, Molding - Scratch &amp; Dent - Large / (R) Rear Fender, Molding - Scratch &amp; Dent - Medium / (R) Rear Door, Molding - Scratch &amp; Dent - Medium / Rear Bumper, Lamps, Panels - Scratch &amp; Dent - Medium / Trunk Hood, Rear Gate - Crack, Gap - Medium / Roof - Scratch - Large / (L) Rear Door, Molding - Scratch - Small / (L) Rear Fender, Molding - Scratch - Small</p> |

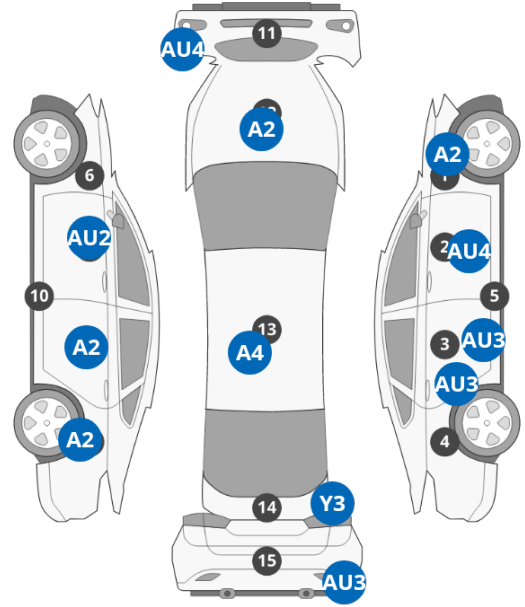
light scratches around the exterior/traction control indicator on/ airbag warning light on/ ABS warning light on/ air-conditioning issue/ possible flooding/ no jack and tools/ no warranty booklet/ no spare tire and LTO plate/ plate light issue/ HPG recovered/
