## General Information

| Make | Toyota | Model | Vios |
| YOM | 2022 | Odo Meter Reading | 61,896 |
| Registration No. | CBD9499 | Chassis No. | PA1B18F3XN4187354 |

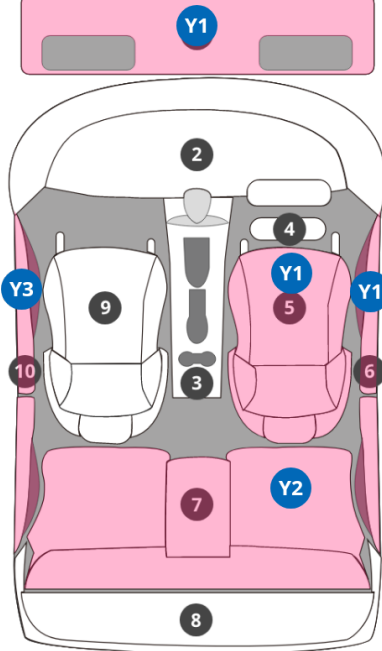
| Interior Evaluation : <b>B</b> | Exterior Evaluation : <b>E</b> |
| <b>Remarks</b><br>Rear Seat - Grime - Small / (R) Front Trim - Grime - Minimal / (R) Front Seat - Grime - Minimal / (L) Front Trim - Grime - Medium / Ceiling - Grime - Minimal | <b>Remarks</b><br>(R) Front Fender, Molding - Scratch - Small / (R) Mirror - Scratch - Minimal / (R) Front Door, Molding - Scratch & Dent - Medium / (R) Step, In-panel, Side Spoiler - Scratch & Dent - Large / (R) Rear Door, Molding - Scratch - Medium / (R) Rear Fender, Molding - Scratch - Large / Rear Bumper, Lamps, Panels - Crack, Gap - Large / Trunk Hood, Rear Gate - Scratch - Medium / (L) Rear Fender, Molding - Scratch & Dent - Large / (L) Rear Door, Molding - Scratch - Large / (L) Front Door, Molding - Scratch & Dent - Medium / (L) Step, In-panel, Side Spoiler - Scratch - Small / (L) Mirror - Scratch - Minimal / Roof - Scratch & Dent - Medium / Roof Spoiler, Molding - Scratch - Medium / (L) Front Fender, Molding - Scratch - Minimal / Front Bumper, Grille, Lamps - Scratch & Dent - Large / Bonnet, Headlight - Scratch - Large / Member (Bolted) - Dent - Yes |

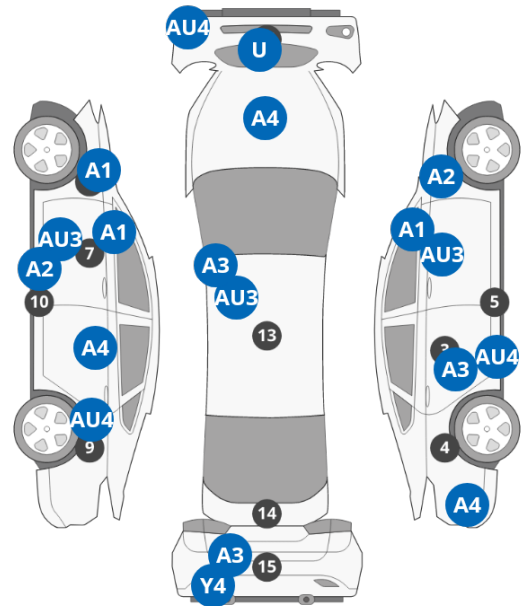
With Lto plate, with jack, 1key, no spare tire and warranty booklet and tools, scratches on headlights and taillights, visible hairlines scratches on vehicle,
