## General Information

| Make | Toyota | Model | Raize |
| YOM | 2023 | Odo Meter Reading | 12,847 |
| Registration No. | NIN4036 | Chassis No. | MHKAA1BA4PJ080393 |

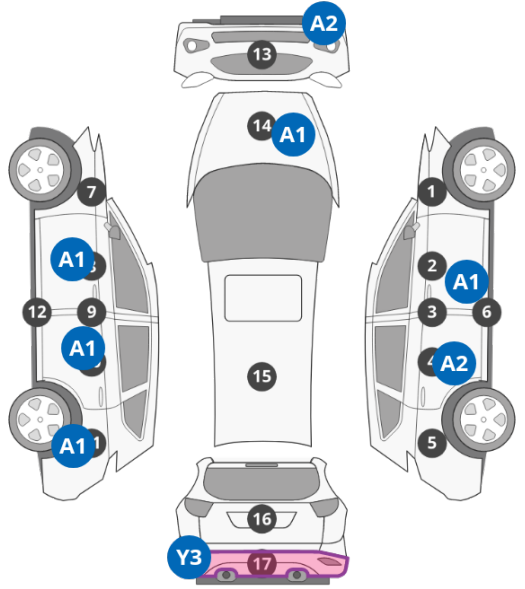
| Interior Evaluation : <span style="color: red; font-weight: bold;">A</span> | Exterior Evaluation : <span style="color: red; font-weight: bold;">B</span> |
|---|---|
| <b>Remarks</b><br>Defects not found | <b>Remarks</b><br>Trunk Hood, Rear Gate - Repair Traces - Yes / Rear Bumper, Lamps, Panels - Repair mark - Yes / Rear Bumper, Lamps, Panels - Crack, Gap - Medium / (L) Rear Fender, Molding - Scratch - Minimal / (L) Rear Door, Molding - Scratch - Minimal / (L) Front Door, Molding - Scratch - Minimal / Bonnet, Headlight - Scratch - Minimal / Front Bumper, Grille, Lamps - Scratch - Small / (R) Front Door, Molding - Scratch - Minimal / (R) Rear Door, Molding - Scratch - Small |

| Inspector Notes |
|---|
| no warranty booklet/ light scratches around the exterior/ no tools/ with jack and spare tire/ with LTO Plate/ |
