## General Information

| Make | Toyota | Model | Vios |
| YOM | 2022 | Odo Meter Reading | 69,163 |
| Registration No. | NFH1442 | Chassis No. | PA1B18F37M4165715 |

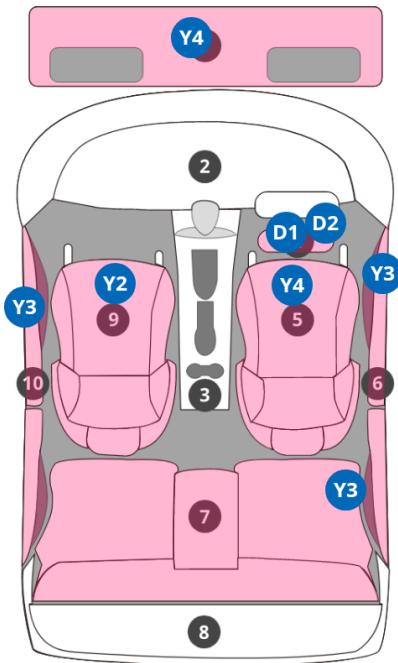
| Interior Evaluation : <b>C</b> | Exterior Evaluation : <b>E</b> |
|---|---|
| <p><b>Remarks</b></p> <p>Ceiling - Grime - Large / (R) Front Seat - Grime - Large / (R) Front Trim - Grime - Medium / Rear Seat - Grime - Medium / (L) Front Trim - Grime - Medium / (L) Front Floor Mat - Worked - Small / Carpet - Worked - Minimal / (L) Front Seat - Grime - Small</p> | <p><b>Remarks</b></p> <p>(R) Front Door - Repair Traces - Yes / (R) Step - Repair Traces - Yes / Bonnet - Repair Traces - Yes / (L) Front Fender - Repair Traces - Yes / (L) Front Door - Repair Traces - Yes / (L) Rear Door - Repair Traces - Yes / (L) Rear Fender - Repair Traces - Yes / Trunk Hood, Rear Gate - Repair Traces - Yes / (R) Rear Fender - Repair Traces - Yes / (R) Rear Door - Repair Traces - Yes / Roof - Repair Traces - Yes / Overall Exterior - Full Re-Paint in same color - Yes / (R) Front Fender, Molding - Scratch &amp; Dent - Small / (R) Front Door, Molding - Repair mark - Yes / (R) Step, In-panel, Side Spoiler - Dent - Large / (R) Rear Door, Molding - Scratch - Minimal / (R) Rear Fender, Molding - Scratch - Small / Trunk Hood, Rear Gate - Scratch - Minimal / Rear Bumper, Lamps, Panels - Scratch - Medium / (L) Rear Fender, Molding - Scratch &amp; Dent - Large / (L) Rear Door, Molding - Scratch &amp; Dent - Minimal / (L) Front Door, Molding - Scratch &amp; Dent - Minimal / (L) Step, In-panel, Side Spoiler - Scratch - Small / (L) Mirror - Scratch - Minimal / (L) Front Fender, Molding - Scratch &amp; Dent - Large / Front Bumper, Grille, Lamps - Crack, Gap - Large / Bonnet, Headlight - Scratch - Minimal / Roof - Scratch - Minimal</p> |

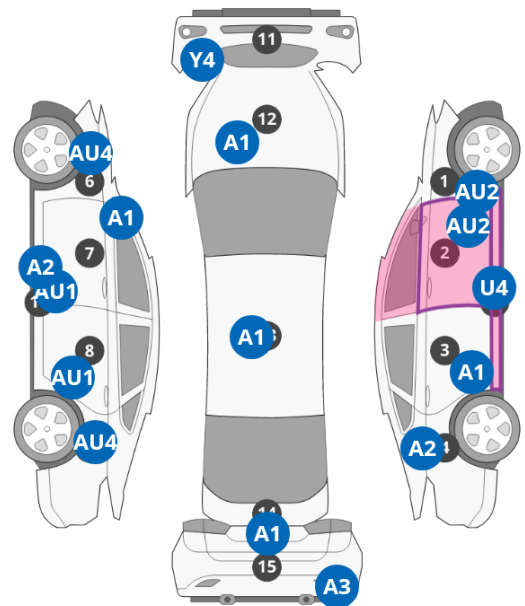
With Lto plate, with spare tire and jack and tools, 1key, no warranty booklet, scratches on headlights and taillights, worn rear tires,
