## General Information

| Make | Toyota | Model | Hiace |
| Registration No. | NDQ7872 | Chassis No. | JTFJT02P0G0002404 |

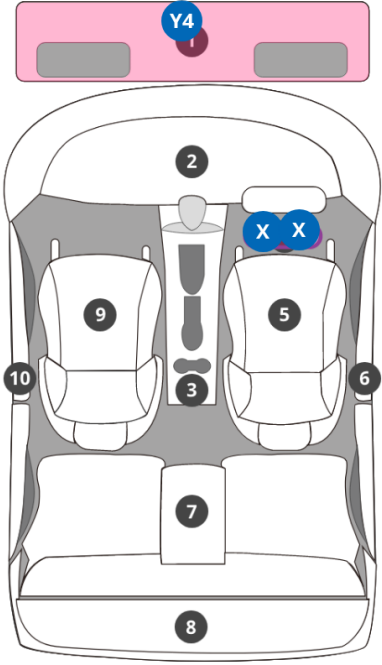
| Interior Evaluation : <span style="color: red;">C</span> | Exterior Evaluation : <span style="color: red;">E</span> |
| <b>Remarks</b><br>(L) Front Floor Mat - Missing - Yes / (R) Front Floor Mat - Missing - Yes / Ceiling - Grime - Large / Overall Interior - Worn as per age - Yes | <b>Remarks</b><br>(L) Front Fender, Molding - Scratch & Dent - Small / (L) Step, In-panel, Side Spoiler - Dent - Small / (L) Front Door, Molding - Scratch - Small / (L) Rear Fender, Molding - Scratch & Dent - Medium / (L) Rear Door, Molding - Dent - Medium / Rear Bumper, Lamps, Panels - Scratch & Dent - Large / Trunk Hood, Rear Gate - Scratch & Dent - Small / (R) Rear Fender, Molding - Scratch - Medium / (R) Rear Door, Molding - Scratch & Dent - Large / (R) Step, In-panel, Side Spoiler - Scratch & Dent - Small / Front Bumper, Grille, Lamps - Scratch & Dent - Large / (R) Front Door, Molding - Scratch - Small / (R) Front Fender, Molding - Scratch - Small / Roof - Scratch & Dent - Large / Bonnet, Headlight - Dent - Small / Front Windshield - Scratch, Stone chip - Small |

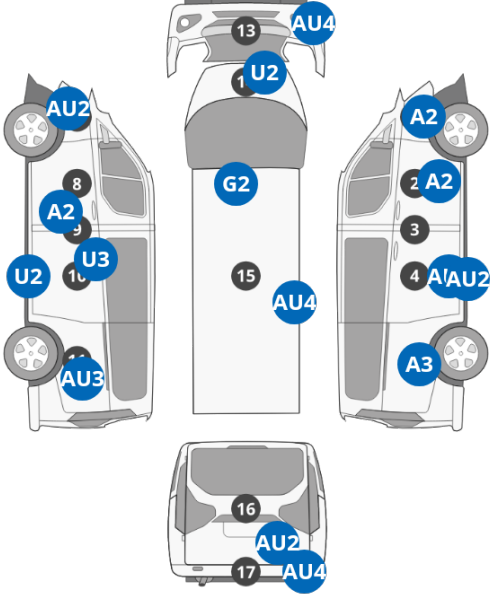
| Inspector Notes |
|---|
| no warranty booklet/ no jack and tools/ light scratches around the exterior/ back door issue/ with LTO Plate and spare tire/ |
